Chapter 8 Repair Considerations

8-6. Repair Examples

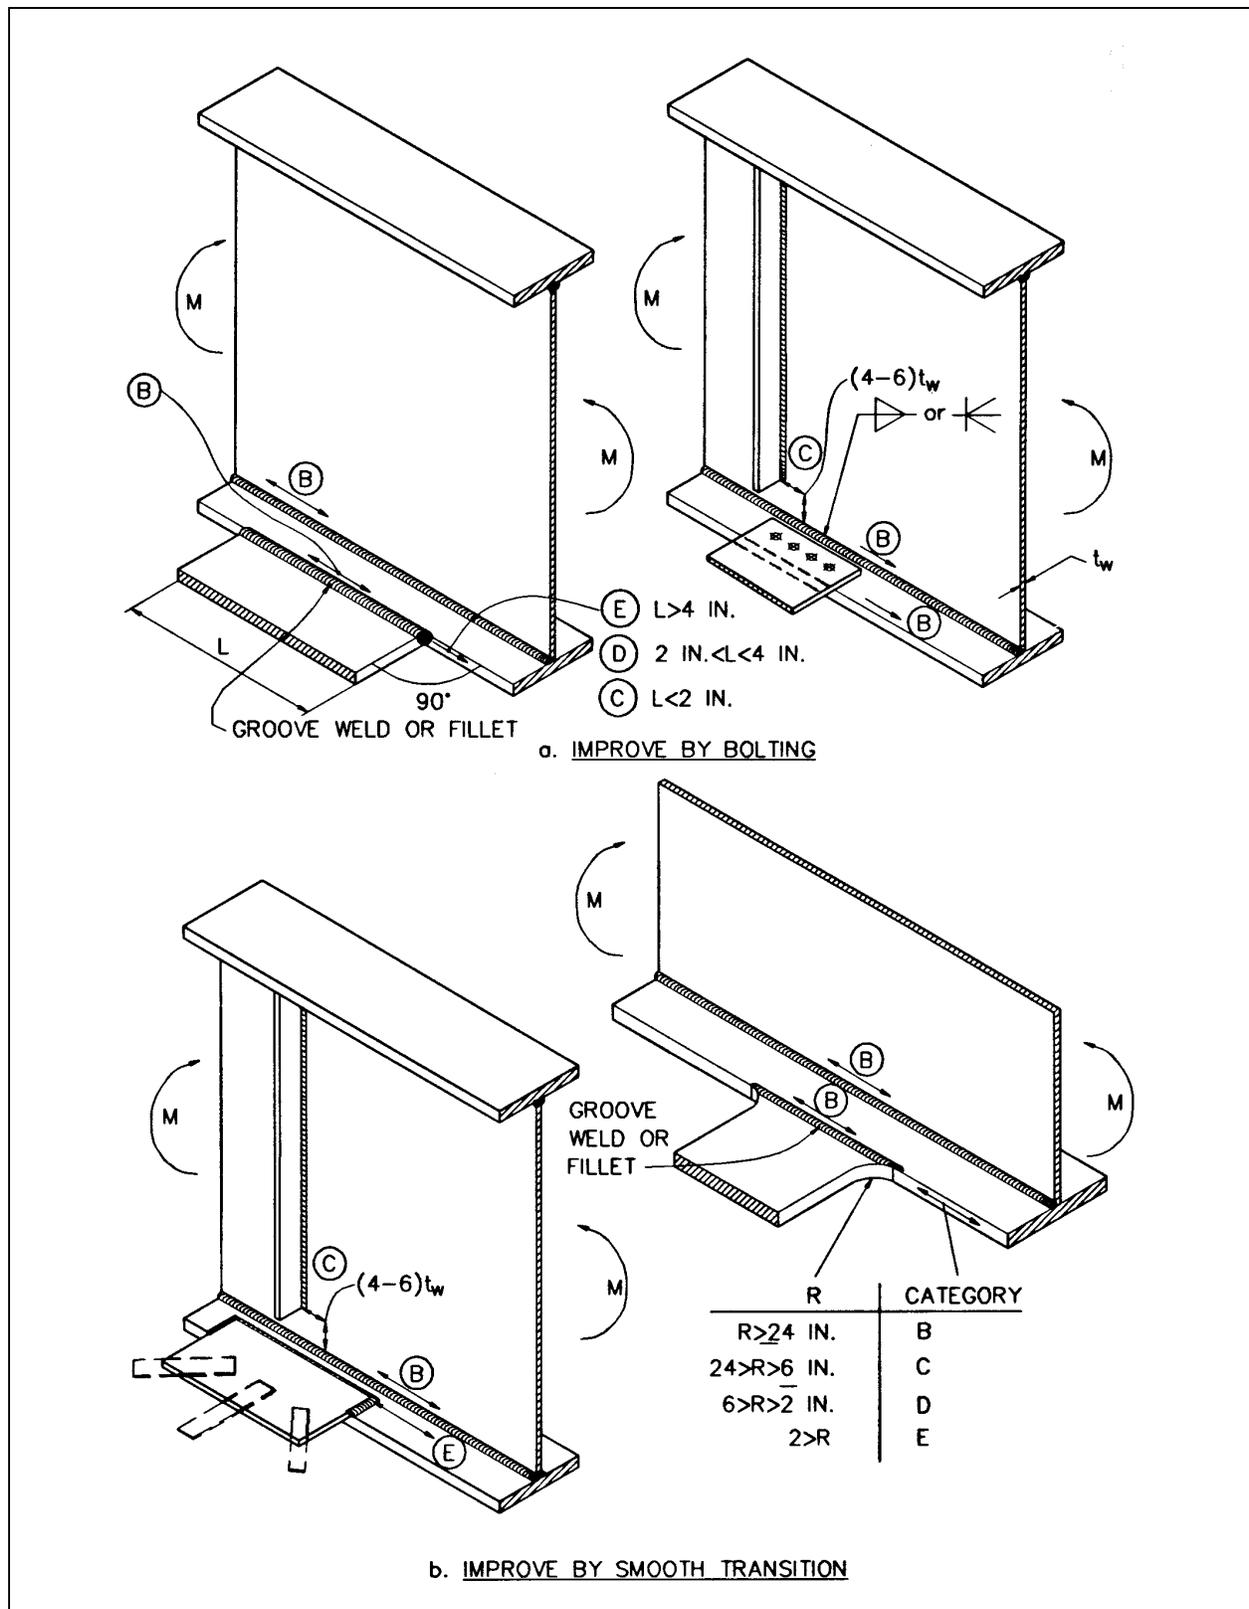
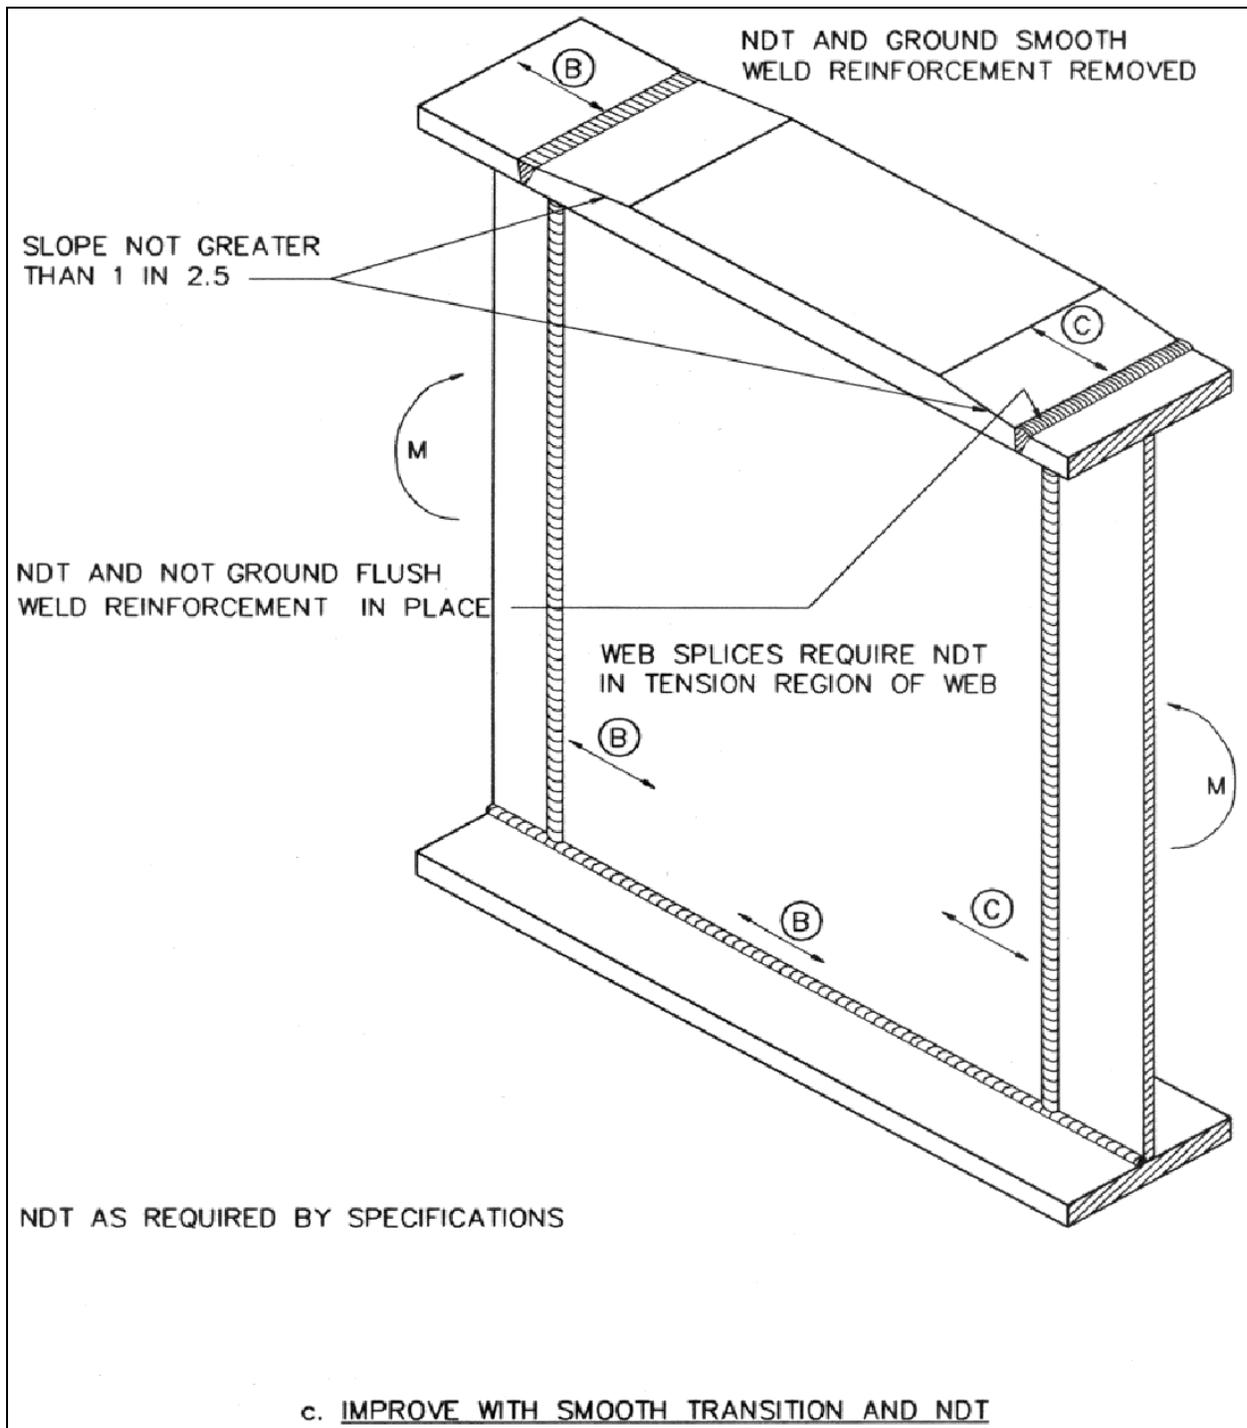
Figure 8-1. Better fatigue details (1 in. = 2.54 cm) (after Fisher 1977) where t_w is the web thickness, M is the bending moment, L is the length of weld considered, and R is the radius on attached component (Continued)

(3) A designer has some flexibility in selecting a detail to minimize likelihood of cracking. For a given condition, various details would serve the same purpose but have different fatigue strength. If budget and other constraints permit, a designer should generally choose the detail with the highest fatigue strength (the least likely to have cracking problems) regardless of loading. In cases of repair, the goal should be to provide a condition with an improved fatigue resistance compared to the original condition. Figure 8-1 shows several situations where a detail can be improved.

(4) If possible, all Category E details should be avoided. Figures 8-1*a* and 8-1*b* demonstrate that other details with higher fatigue strength may be substituted for Category E details. The gusset plate attachments on the left sketch in each figure produce a Category E in the girder flange at the termination of the longitudinal welds or where there is a transverse weld. The Category E situation can be avoided by using a bolted connection (category B) or a gusset plate with a full-penetration weld ground smooth and a generous radius. In both cases, the stress concentration condition has been improved dramatically. Another way to avoid the adverse effects of Category E details is to locate the detail in a region of low stress. Cover plates can be extended to a region of low flexure, and attachments to flanges can be moved to the web where the flexural stress is low.

(5) Fatigue strength can be improved significantly by providing a smooth transition between connected elements as shown in Figures 8-1*b* and 8-1*c*. A flange attachment can be improved from a Category E to a Category B detail by providing a radius transition and grinding the weld smooth (Figure 8-1*b*). The fatigue strength of a transverse groove weld is improved from a Category C to a Category B by removing the weld reinforcement and grinding the weld smooth (Figure 8-1*c*) (see groove welded connections of Table 2-1). Other important considerations are to avoid intermittent welds on backup bars and discontinuous backup bars. A category E situation exists at the termination of each intermittent weld, and a built-in crack exists where a backup bar is discontinuous.

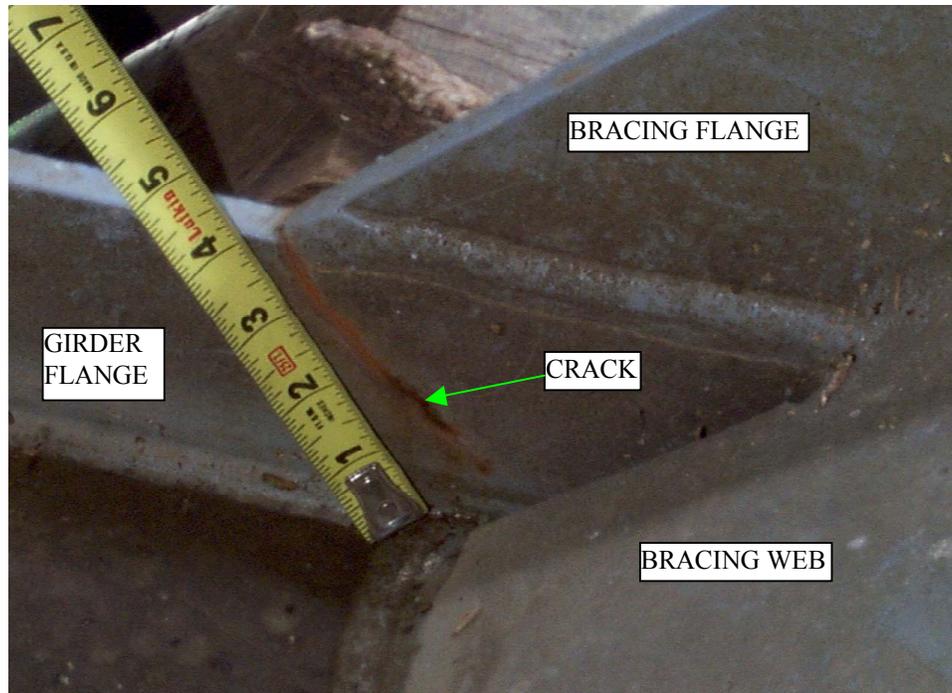
(1) Description of condition. Figure 8-2 shows a crack in a tension flange of a girder on a miter gate (the photograph shows the inside face of the flange). The crack extends from the termination of a weld joining the flange of a diagonal bracing member and flange of the girder. Similar cracking occurred at perpendicular intersecting members (diaphragm and girder). Numerous through-thickness cracks similar to this occurred on the structure.

(2) Cause of cracking. In general, cracking is attributed to high stress fatigue damage of low fatigue strength details. Cyclic loading occurs due to opening and closing of the gate leaves and to variation in hydrostatic pool. Unusually high stress may have occurred due to unintended loading while the gate was opened and closed with silt buildup at the gate bottom. Most of the cracks occurred at terminations of welds that join intersecting members, similar to the condition shown in Figure 8-2. Considering girder flexure, the fatigue strength of such details is Category E.

Figure 8-2. Crack in miter gate girder tension flange

(3) Repair alternatives. The following repair alternatives were developed for the miter gate. The types of cracks found on this structure are common to hydraulic structures that have experienced cracking. The presented alternatives are generally applicable to similar situations on all gates.

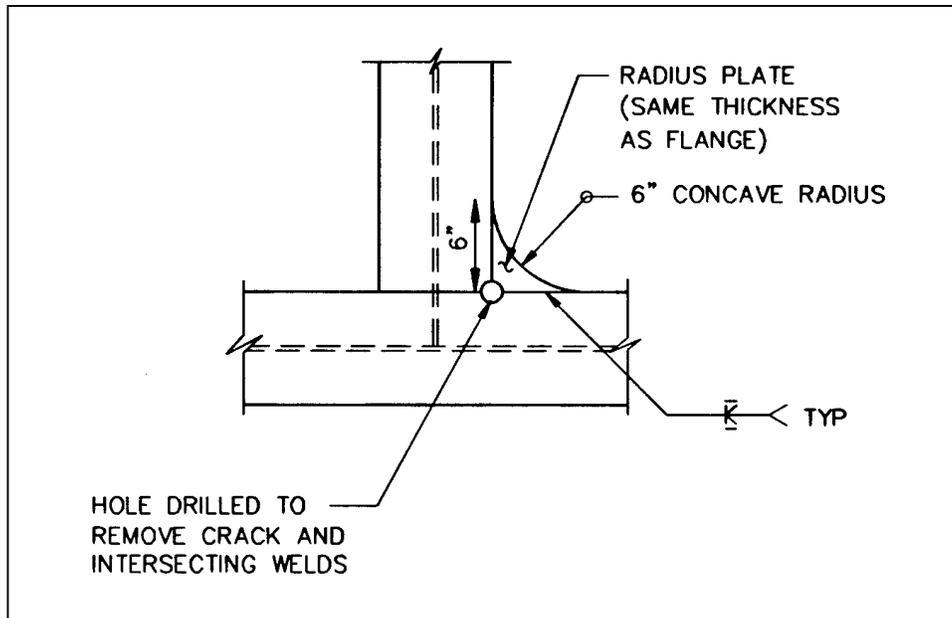
Figure 8-3. Retrofit to improve fatigue strength at intersecting perpendicular members (1 in. = 2.54 cm; 1 ft = 0.3 m)

(a) Figure 8-3 shows a repair procedure that was developed for small cracks (less than 12 mm (1/2 in.)) located at re-entrant corners of perpendicular members. The area should be cleaned and prepared as necessary to locate and mark the crack tip using dye penetrant testing. The radius plate should then be installed using a full-penetration weld with welding in accordance with ANSI/AWS D1.1. The plate should be of the same (or similar) thickness as the adjacent plates (flanges). A 25-mm (1-in.) hole should then be drilled to encompass the crack and to remove the weld intersection. Penetrant testing should be conducted to verify removal of the crack tip, and the area should be repainted. Even if cracking has not occurred, this repair could be used to retrofit poor conditions found at intersecting perpendicular members (i.e., diaphragm and girder) on any structure. The retrofit shown (with radius of 15 cm (6 in.)) improves the fatigue strength from Category E to Category C.

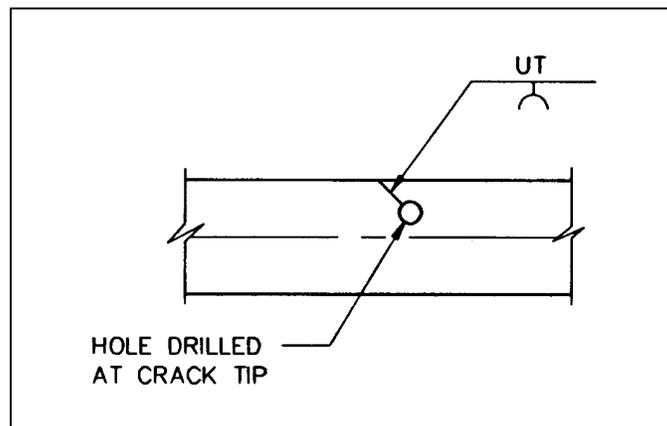
Figure 8-4. Weld repair for edge crack

(b) Figure 8-4 shows the selected repair for edge cracks greater than 25 mm (1 in.) The repair should be completed following the guidelines for welded crack repair given in paragraph 8-4a. Any type of full-penetration weld is acceptable. For edge cracks that extend into the web, a repair similar to that shown in Figure 8-4 is appropriate. However, some additional steps are required. A crack that extends into the web has a crack tip in the flange opposite that where the crack initiated and in the web. Holes should be drilled at both locations. Additionally, a weld access hole should be cut in the web to accommodate the full-penetration flange weld. The access hole should be proportioned in accordance with ANSI/AWS D1.1. Any type of full-penetration weld is acceptable.

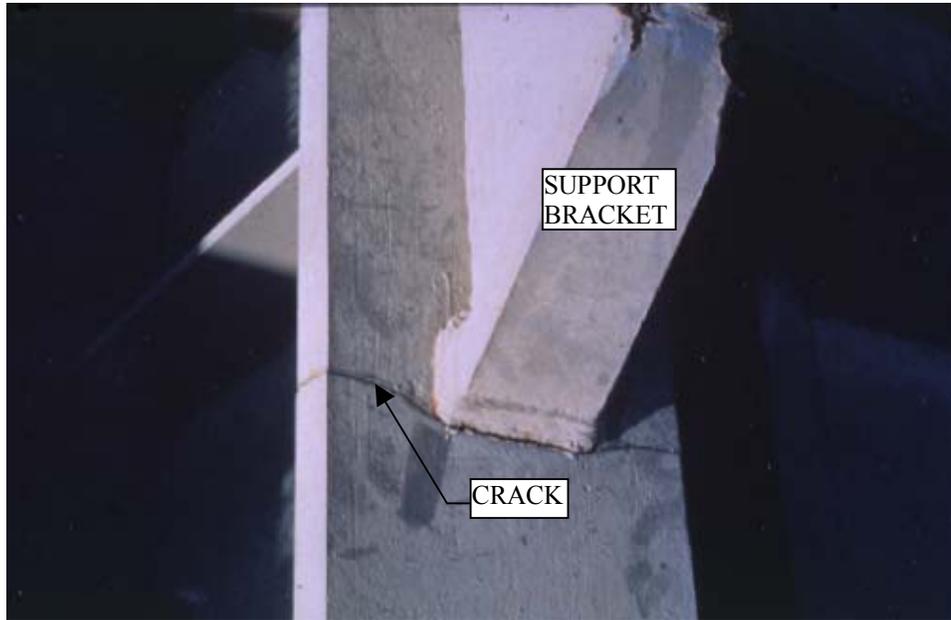
(1) Description of condition. Figure 8-5 shows a connection bracket that is welded to the downstream flange of a vertical girder in a spare vertically framed miter gate. The gate consists of 3-m- (10-ft-) high welded modular sections that are stacked vertically and joined by bolts that extend through the connection

bracket. The gate was fabricated in 1969 and had been installed several times for temporary use. While in service, the gate did not have any loading greater than the design load. In 1989, it was discovered that the downstream flanges on three of seven vertical girders were cracked as shown in Figure 8-5. In each case the crack extended through the 38-mm- (1-1/2-in.-) thick flange and approximately two-thirds of the way through the web.

(2) Cause of cracking. The crack was located in the tension flange of the vertical girder at the intersection of the bracket plate and the flange plate. The weld that joins the bracket plate and flange plate is transverse to the direction of stress flow, and the intersection of the two plates creates a severe stress concentration for stress flow through the flange. This situation is similar to that at the end of a welded cover plate and would be classified as a category E fatigue detail. Considering the quality of weld, the actual condition is worse than a Category E. The general weld profile is rough and undercut, which essentially creates a small initial crack. The cracking in three of seven girders illustrates the adverse effects of this type of stress concentration.

Figure 8-5. Cracked miter gate vertical girder tension flange

(3) Repair alternatives. Due to the general configuration and restrained geometry of this connection, a repair that restores the original intended strength may be difficult to achieve. However, the crack can be repaired using splice plates on the flange and web. The splice plates could be welded or bolted. A bolted repair would result in a Category B detail; however, due to the constrained geometry, the effective area considering the required bolts may be a concern. A welded repair would result in a Category E condition at the end of the splice plates. (However, with modern welding practices, the condition would be improved over that of the original connection.) To minimize the effect of the Category E, the splice plates could be extended into a region of low stress. For either a welded or bolted repair, a hole should be drilled at the crack tips. Prior to cracking, the condition could have been improved by grinding the weld profile smooth, or by retrofitting the welds by peening or GTA remelting procedures. A similar modification was undertaken on an extensive retrofit of the Yellow Mill Pond Bridge in the early 1980s (Fisher 1984).

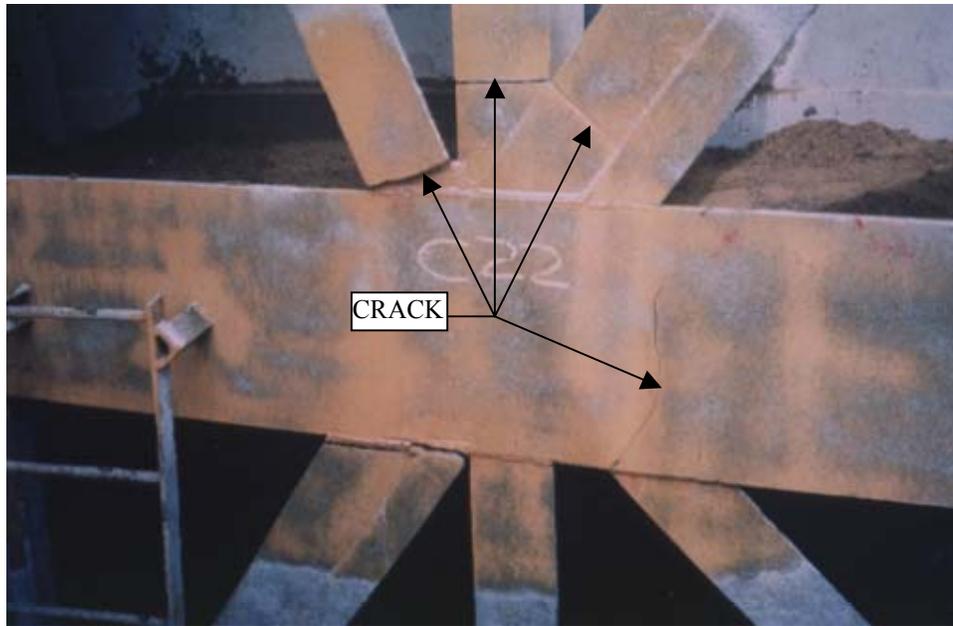
(1) Description of condition. Figure 8-6 shows a connection between a vertical diaphragm, diagonal bracing members, and a main horizontal girder on a vertical lift gate. This type of connection (intersection of bracing members, diaphragms, and girders) is a very common occurrence on lift gates, miter gates, tainter gates, and bridges. Flanges of bracing members and the diaphragm were each welded directly to the girder flange. Cracking occurred completely through each bracing member and through the diaphragm flange and girder flange (at various locations on this particular structure). The girder is designed to resist flexural forces imposed by hydrostatic pressure, and under this condition, the downstream flange is subject to tension. The bracing members are designed as members of a truss that resists vertical loads imposed by the gate weight and water pressure. Therefore, the bracing members are presumably subjected to axial tension or compression. Field measurements have shown that out-of-plane displacement and rigidity of end connections may also impose flexure in the bracing members (Commander et al. 1994).

Figure 8-6. Cracked girder, diaphragm, and bracing in a lift gate

(2) Cause of cracking. The location and orientation of cracks indicate that cracking initiated at weld terminations and weld intersections. The re-entrant corners between members and the inferior weld geometry (overlapping welds, transverse to stress and not ground smooth) both create a critical stress concentration condition for the stress flow through the girder flange, diaphragm flange, and bracing members. The attachment to the girder tension flange is a Category E, and considering axial behavior of intersecting members, a Category C, D, or E situation exists depending on the thickness of joined elements. (With overlapping welds and poor weld profiles, the strength is likely less than that of a Category E detail.)

(3) Repair alternatives. It is necessary to restore the girder strength and to provide adequate connections of the intersecting members. To avoid future fractures, the repair details should improve the original condition if possible. Various alternatives could be used to repair the girder while improving the original condition:

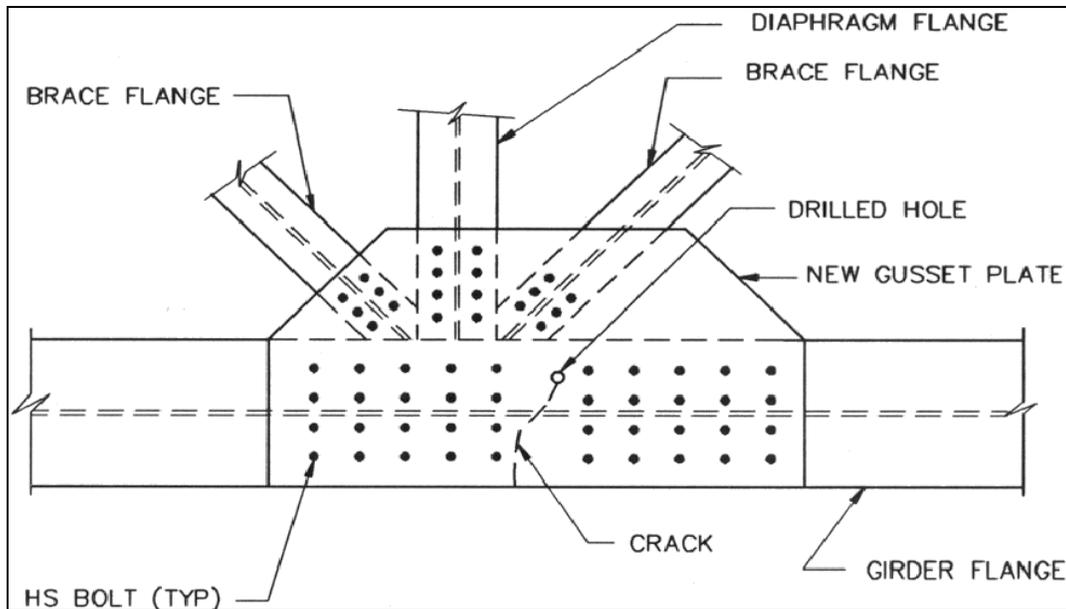
Figure 8-7. Bolted repair alternative for cracked lift gate

(a) One alternative would be to drill holes at the ends of each existing crack and to add a bolted gusset plate as shown in Figure 8-7. The gusset plate would be sized such that the plate and connected flanges would resist the required forces considering the net area. This alternative would improve the fatigue strength to Category B; however, due to the number of bolts required and the resulting reduction in net area, a very large plate would likely be necessary.

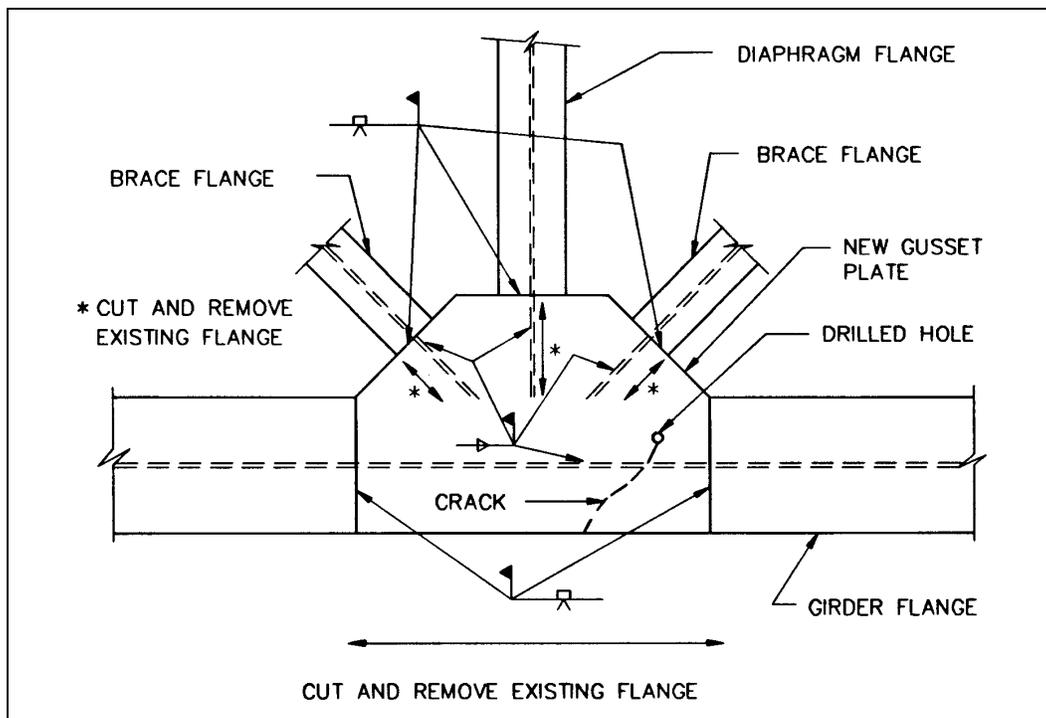
Figure 8-8. Welded repair alternative for cracked lift gate

(c) A better detail is shown in Figure 8-8. This would require removing a specified length of flange from each of the intersecting members and replacing the flanges with a single gusset plate. All of the member flanges would be welded to the gusset plate with full-penetration groove welds, and the member

webs would be welded to the gusset plate with full-penetration or fillet welds. Web access holes are required at flange welds and should be prepared in accordance with ANSI/AWS D1.1. The exact configuration should be determined to avoid intersecting welds. With this approach, the detail would improve from a Category E to a Category C or B depending on weld profile and weld inspection requirements (see requirements for groove welded connections in Table 2-1).

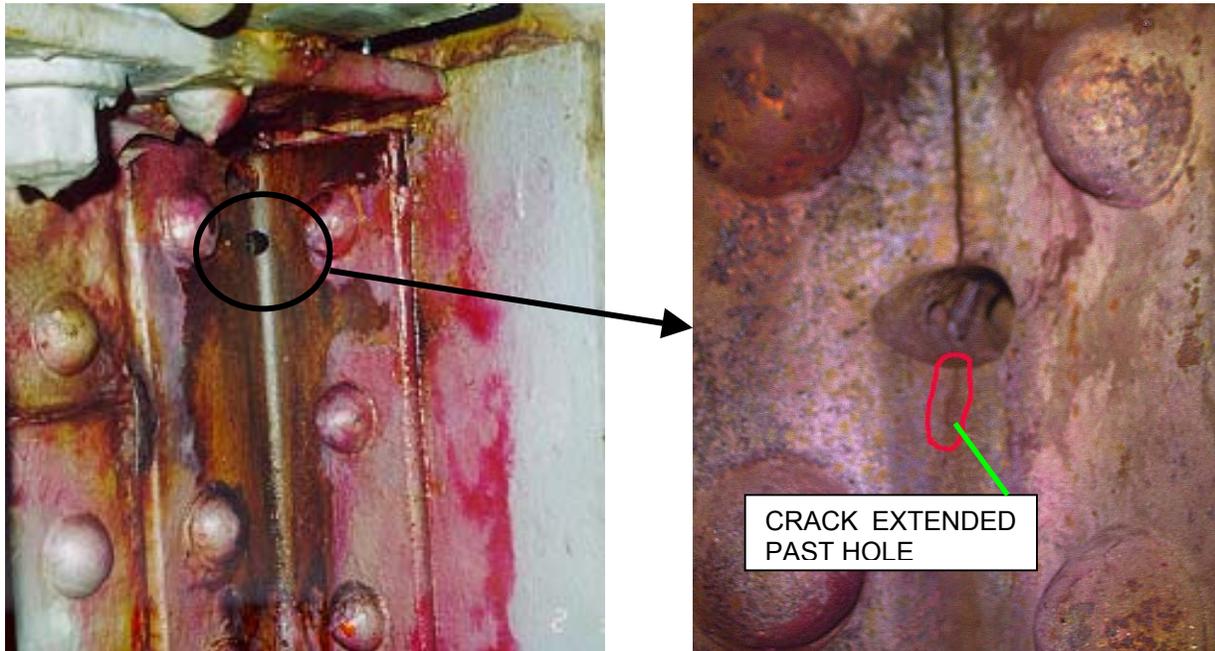
(1) Description of condition. Figure 8-9 shows a crack in a connection angle that attaches a floor beam to one web of a box girder in a USACE tied arch bridge. The crack extends from the upper edge of the connection angle downward along the fillet of the angle. The cracks were discovered after approximately 40 years of service. Similar cracks have been found in at least four connections. The cracks were repaired by drilling a hole at the end of the crack approximately 6 years ago. Recently, cracking through the hole was observed in at least one location.

Figure 8-9. Crack in bridge floorbeam connection angle

(2) Cause of cracking. For the purposes of this example, it is assumed that floor beam flexural forces cause unintended distortion of the connection angle that was not accounted for in the design. The connection is assumed to be a simple shear connection and was not designed to resist floor beam flexure. However, the angle actually resists out-of-plane forces due to connection rigidity, and the crack driving force is apparently due to the floor beam flexure. The prior repair, which consisted of drilling a hole at the end of the crack, served to arrest the crack temporarily. However, since the out-of-plane displacement is not restrained and the floor beam flexure still exists, the crack has reinitiated from the hole.

(3) Repair alternatives. To eliminate the cause of cracking, the connection must be modified to reduce the inherent rigidity (to minimize bending forces) or to increase the rigidity (to minimize the out-of-plane displacement of the connection angle). Cases similar to this are discussed by Keating (1994) and Fisher (1984).

(a) Simple connection. One alternative is to alter the floor beam connection detail to reduce the connection rigidity such that minimal flexure is imposed at the end of the floor beam. This would eliminate the driving force that causes the out-of-plane distortion of the angle. Although many repair details could be designed to serve this purpose, one possibility would be to remove rivets at the top of the angle and to cut away the corresponding length of angle to reduce the angle length. To account for the lost shear strength, a seat angle could be added at the bottom of the floor beam. This alternative would

maintain the required shear strength and would reduce the connection rigidity that causes crack driving force.

(b) Rigid connection. Another alternative would be to reinforce the connection to prevent the distortion. This could be done by attaching the top flange of the floor beam to the box girder web using a tee section with its flanges bolted to the box girder web and its web bolted to the top flange of the floor beam. The top portion of the existing connection angle would have to be removed to provide room for the tee flange. Although the displacement of the original connection angle would be controlled, large flexural forces would develop at the end of the floor beam due to the connection rigidity. This may result in other problems such as distress of the girder web, since the connection was designed as a simple connection.

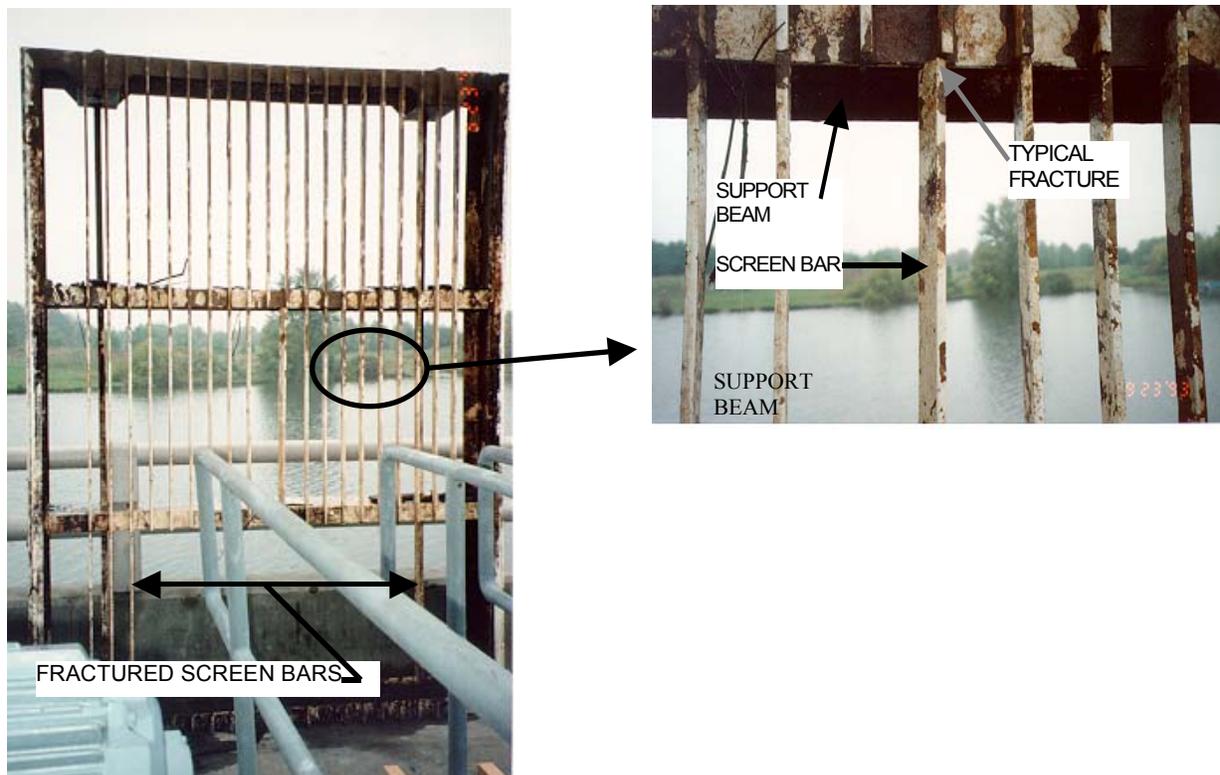
(1) Description of condition. Figure 8-10 shows a trashrack used at an inlet structure on a dam. The trashrack is composed of a steel outer frame, two support beams, and several screen bars that span the frame across the support beams. The bars were attached on the upstream face of the rack with the edges of the bar welded directly to the support beams and frame with fillet welds. Seventeen out of twenty of the bars fractured completely as shown in Figure 8-10. In each of the fractured bars, the cracks initiated at the end of the weld that joins the bar to the supporting member (on the downstream edge of the bar).

Figure 8-10. Fractured screen bars on dam intake trashrack

(2) Cause of cracking. Design loads consisted of lateral hydrostatic loads that induce flexure in the bars. The direction of bending in the bar at the welds is such that the design stress is compressive on the downstream edge of the bar at the crack locations. Therefore, under design assumptions, cracking is not expected. The cracking is attributed to tensile fatigue stresses caused by out-of-plane distortion of the bars

as they are vibrated by passing water. The weld termination and abrupt change in geometry between the bar and supporting member create a severe stress concentration resulting in a detail with low fatigue strength. Even with vibration due to passing water, the cracking might not have occurred given connection details with higher fatigue strength.

(a) The attachment between the screen bars and supporting members creates a severe stress concentration condition that could be avoided by using a different type of connection. Similar trashracks have been designed where the supporting members have carefully sized holes through which the screen bars pass and there is no need for a welded attachment. This eliminates the stress concentration at the weld, and it is likely that the screen bars would have a significantly longer life. The actual repair for this case is shown in Figure 8-11. New screen bar supports with holes (retainer bars) were fabricated and attached to the existing channel support members with bolts. The bars were then threaded through the retainer bar holes and held in place by angles at the bar ends oriented perpendicular to the bars and attached to the existing frame with bolts.

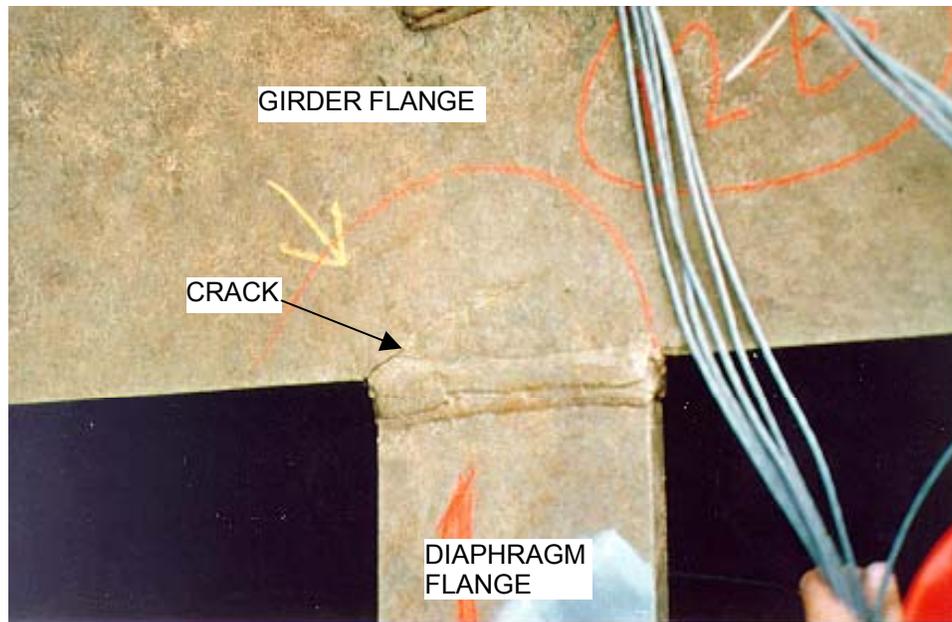
(1) Description of condition. Figure 8-12 shows a crack in the downstream girder flange of a vertical lift gate. The crack initiated at the end of the weld between a diaphragm flange and downstream girder flange and propagated into the girder flange. The fatigue strength of the girder flange at the weld termination is analogous to Category E. Under typical design assumptions, the girder is in flexure due to lateral hydrostatic forces and the downstream flange is subject to tensile stress. If cracking were to occur considering design assumptions, the expected direction of cracking in the girder flange would be transverse to the flange (perpendicular to flexural tensile stress). However, the crack is oriented at approximately 45 degrees to the horizontal girder flange.

(2) Cause of cracking. The crack is located at the re-entrant corner between flanges (a severe stress concentration condition), and tensile cyclic stress exists in the flange at this location. The cracking is attributed to fatigue cracking of a detail with low fatigue strength. It is also presumed that the condition was exasperated by out-of-plane distortion of the girder flange. Under vertical hydrostatic loading on the lift gate, the horizontal girder flanges displace in a vertical plane similar to a uniformly loaded simple beam as shown in Figure 3-5. The figure illustrates displacement of downstream girder and diaphragm flanges due to vertical loading. The ends of diaphragm flanges are forced to rotate with the displaced girder flanges causing out-of-plane flexure in the diaphragm flanges. This induces stresses acting parallel to the diaphragm flange with tension on one edge and compression on the other as shown in Figure 3-5. Experimental measurements of lift gate stresses verify this behavior (Commander et al. 1994). At the point of crack initiation, longitudinal tension stresses exist in both the girder flange (due to lateral hydrostatic loading) and diaphragm flange (due to out-of-plane distortion). The combined effect of these perpendicular tensile stresses results in a primary tensile stress that acts perpendicular to the direction of the existing crack.

Figure 8-12. Cracked girder tension flange at diaphragm of a lift gate

(a) The ideal crack repair would also improve the fatigue strength of the detail and would eliminate the out-of-plane distortion. However, to eliminate the displacement shown in Figure 3-5 would require significant structural modification, and the cracking might not have occurred given connection details with higher fatigue strength. The fatigue strength of the detail would be improved by providing a smooth radius between the diaphragm flange and girder flange. This would improve the stress concentration condition and could theoretically improve the fatigue strength from Category E to Category B (see condition 16 of Table 2-1). The recommended repair is a combination of crack repair procedures shown in Figures 8-3 and 8-4. First, repair the crack according to Figure 8-4 while following the guidelines for welded crack repair given in paragraph 8-4a. Then add the radius plate and drill the hole as shown in Figure 8-3 and as described in paragraph 8-6a(3).

(b) Another possible alternative would be to install a bolted repair similar to that shown in Figure 8-7 (a similar repair is described in paragraph 8-6c(3)). Before the bolted repair is installed, the crack tip should be drilled and the diaphragm-flange-to-girder-flange weld should be removed to eliminate the stress concentration.

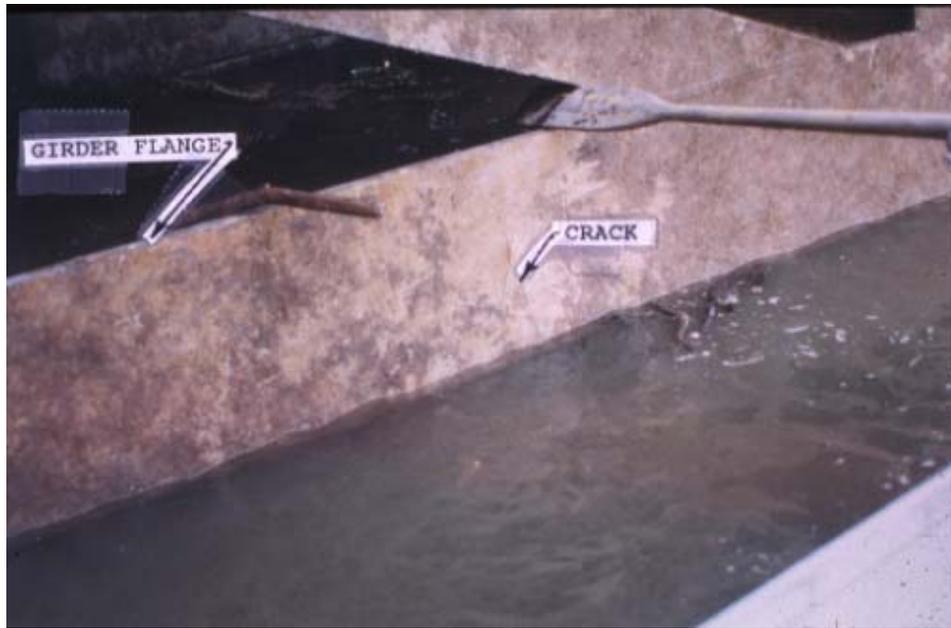
(1) Description of condition. A through-thickness crack that extends through the tension flange of a built-up girder on a vertical lift gate is shown in Figure 8-13. The structure had been in service for less than 2 years at the time the crack was discovered. The crack is located where an uncoped transverse web stiffener is attached. The crack apparently initiated at the intersection of the three welds (web-to-flange,

Figure 8-13. Cracked girder tension flange of a lift gate

stiffener-to-web, and stiffener-to-flange). Figure 8-14 shows the intersection of welds where the girder web, girder flange, and stiffener are joined.

(3) Repair alternatives. Prior to cracking, a general retrofit for uncoped stiffeners is to drill a hole in the stiffener adjacent to the intersection and grind all surfaces smooth. The drilled hole removes the weld intersection and effectively serves as a cope. A similar type repair has been completed on web connection plates that intersect with transverse web stiffeners (Fisher 1984). The actual repair of this condition consisted of a bolted splice plate (Figure 8-15). Ideally, the stiffener should have been drilled near the intersection (as previously described) before the splice plate was installed. Additionally, the crack tip should have been located and drilled out. With this repair, the crack is isolated and the fatigue strength is improved to Category B. It is possible that a welded repair (similar to that described in paragraph 8-6a(3) for a crack that extends into the web), could have been completed. However, such a weld repair would have been difficult or impossible with the existing stiffener located adjacent to the crack.

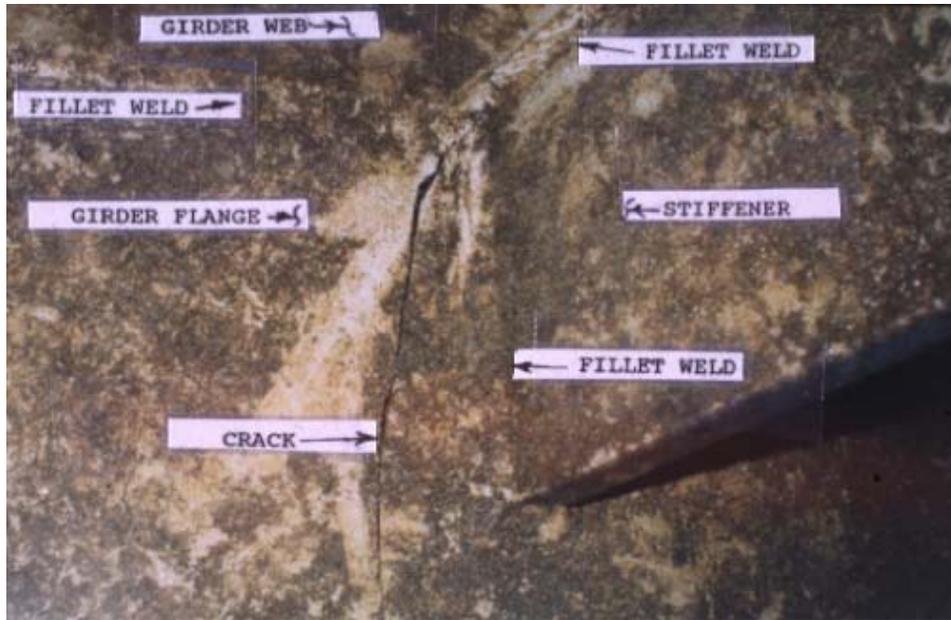
(2) Cause of cracking. The three intersecting welds (web-to-flange, stiffener-to-web, and stiffener-to-flange) each contract during cooling and contain tensile residual stresses creating a state of triaxial tension stress. Under the condition of triaxial tensile stress, steel cannot yield and an extremely brittle condition exists. Additionally, at locations of intersecting welds, there is often a lack of fusion at the end of one or both stiffener welds. This results in an embedded discontinuity. The fatigue category considering girder flexure is a Category C for a stiffener coped per American Association of State Highway and Transportation Officials (AASHTO) requirements (minimum cope dimension is required to be at least 4 times the thickness of the web). However, the described condition has much lower fatigue strength due to the increased brittleness and likelihood of embedded discontinuities. The use of uncoped stiffeners should always be avoided; however, there are many such cases in existing USACE structures. A similar condition exists in many vertical lift gates and miter gates where built-up girders and diaphragms intersect. If the diaphragm web is not coped, intersecting welds exist (girder-web-to-girder-flange weld, diaphragm-web-to-girder-web weld, and the diaphragm- web-to-girder-flange weld).

Figure 8-14. Intersecting welds at web stiffener of the girder shown in Figure 8-13

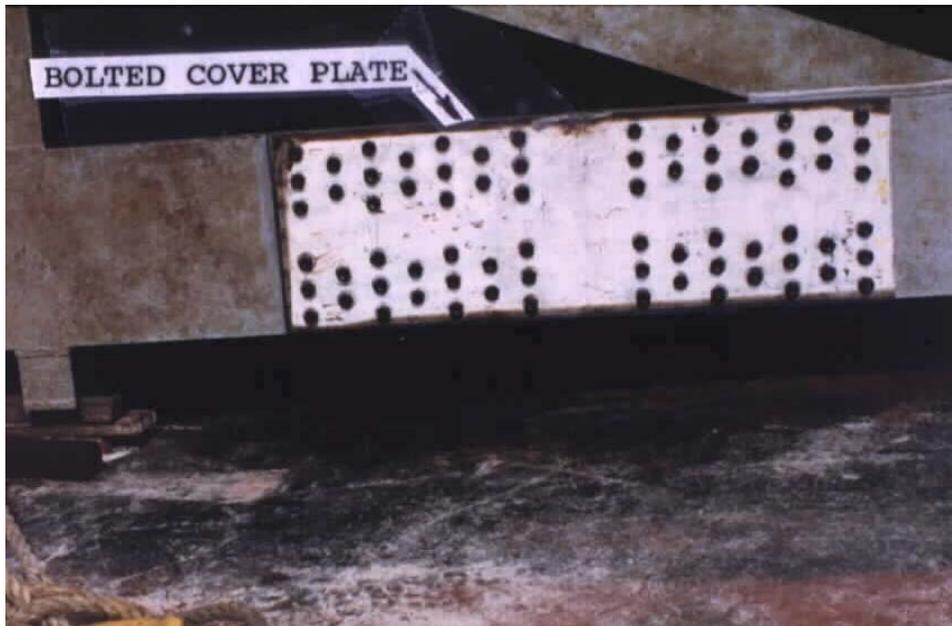
Figure 8-15. Bolted repair splice for the girder shown in Figure 8-13

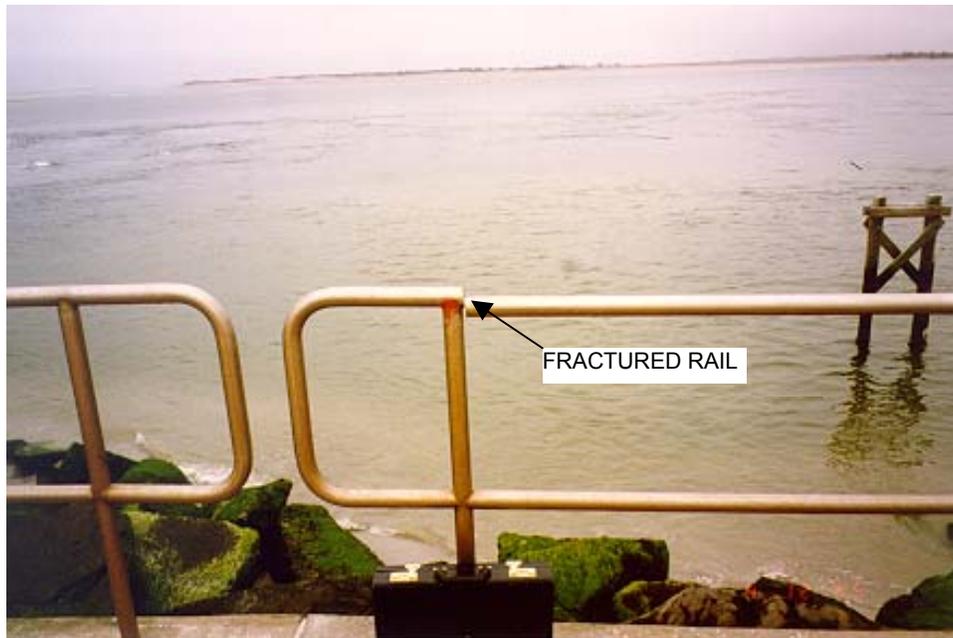
(1) Description of condition. After less than 2 years of service, severe cracking occurred at numerous locations on a welded steel handrail (Figure 8-16). The basic railing configuration is shown in Figure 8-17. All railing consists of 38-mm (1-1/2-in.) stainless steel pipe. The top rails are continuous and are fillet welded to the top of vertical posts. The bottom rails consist of segments of pipe fillet welded at each end to the vertical posts. Considering flexure in the rails, the fatigue strength of the rails at

Figure 8-16. Cracked steel handrail

the post is similar to Category C. Vertical cracks (perpendicular to the rails) located at the outer edges of the posts occurred in the top and bottom rails at numerous locations. Several of the cracks propagated through the pipe.

(2) Cause of cracking. Cracking is attributed to high cycle fatigue. A laboratory analysis was conducted on one of the failed pipes to determine the cause of cracking. The analysis showed that the crack

initiated at the weld toe and propagated to failure under high cycle vibration loading. Field observations confirmed that the rails vibrated with significant midspan displacement when subjected to wind loading.

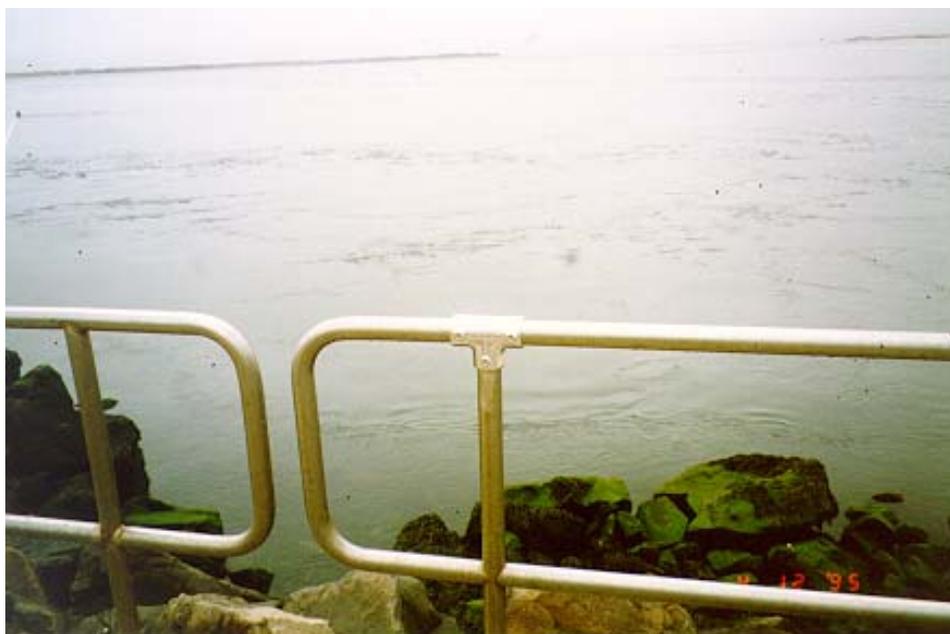
Figure 8-18. Bolted tee connection retrofit of fractured hand rail

(3) Repair. The handrails were repaired with bolted tee and cross fittings fabricated to fit snugly around the intersecting pipes (Figure 8-18). The fittings consist of two pieces that sandwich the pipe like two halves of a sleeve to form a bolted splice. The first repair fittings were aluminum because steel fittings were not available. Therefore, corrosion was also a consideration since stainless steel and aluminum are dissimilar metals. To protect the aluminum from corroding, an electric isolater that consisted of a thick epoxy-based paint was applied to the inside surface of the fittings. After 2 to 3 years, the aluminum fittings had corroded significantly. The fittings have since been replaced with custom-manufactured stainless steel fittings. This repair improved the original fatigue strength from Category C to Category B. In addition, the rails are now more flexible since their end connections are no longer rigid. This may improve the vibration problem (similar to the discussion of repair of the trashrack bars in paragraph 8-6e).
