Appendix L

Photos

Fish-Cleaning and Sewage Dump Stations

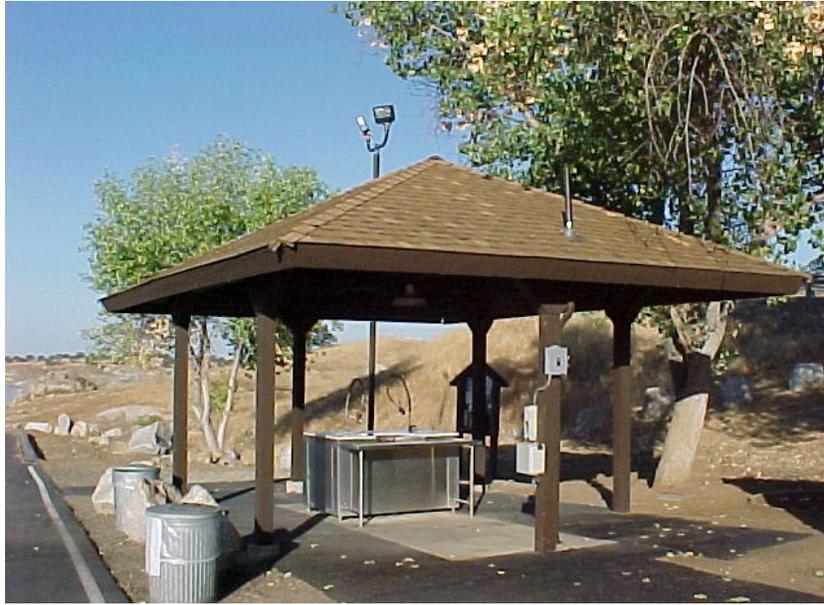
Photo L-1. Fish-cleaning station. Hensley Lake, CA. Note that this fish-cleaning station is shaded and protected from the elements, is UA, is located within 50 ft of parking area, has interior and exterior lighting fixtures, and is isolated from other activities (Table 3.10)

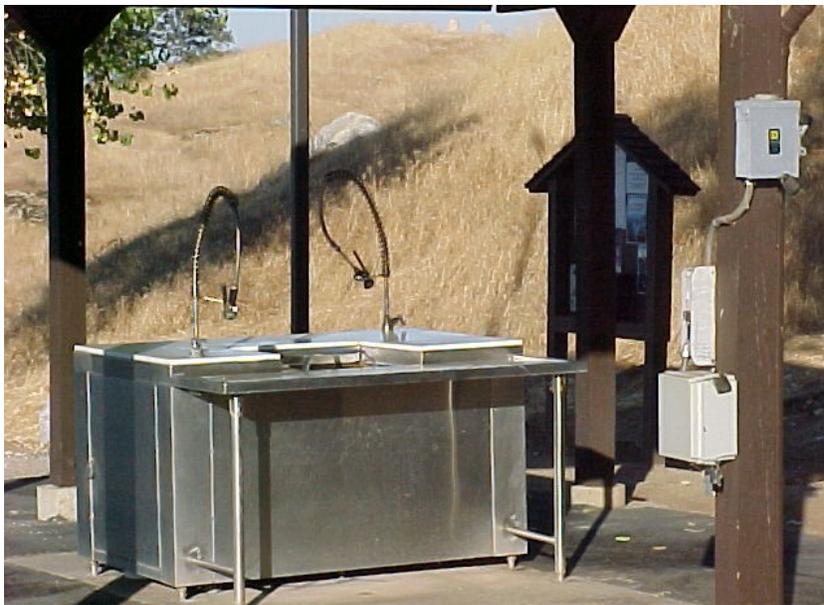
Photo L-2. Interior view of fish-cleaning station. Hensley Lake, CA. Note that this fish-cleaning station has a UA maneuver area, is sited on a concrete pad, and that two water hydrants are provided (Table 3.10). UA utility sink should be a feature of new units

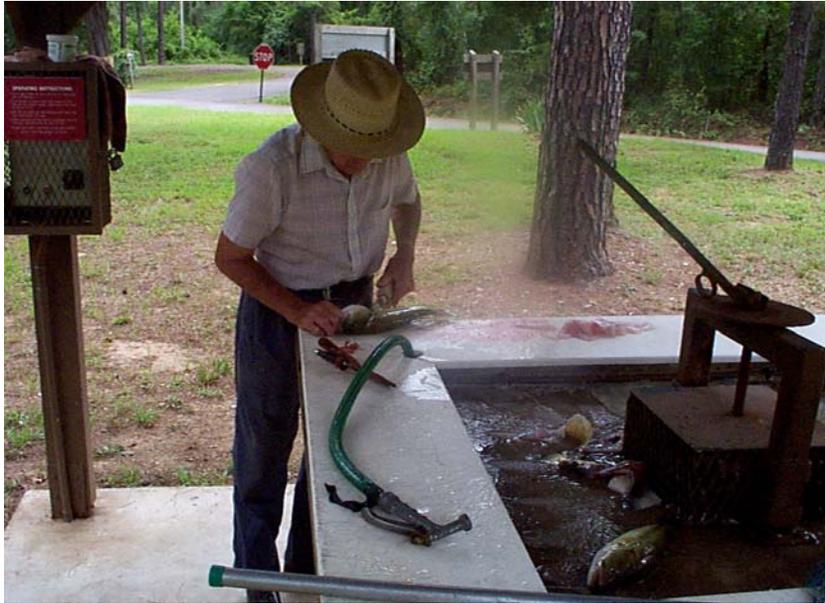
Photo L-3. Customer using fish-cleaning station. Carter Cove Park, Nimrod Lake, AR. This station includes two water hoses with spray nozzles, a 2-hp grinder with timed start/stop switch and custom cover (fish remains go into septic tank and leach field), GFCI receptacles, and night lighting ([Table 3.10](#))

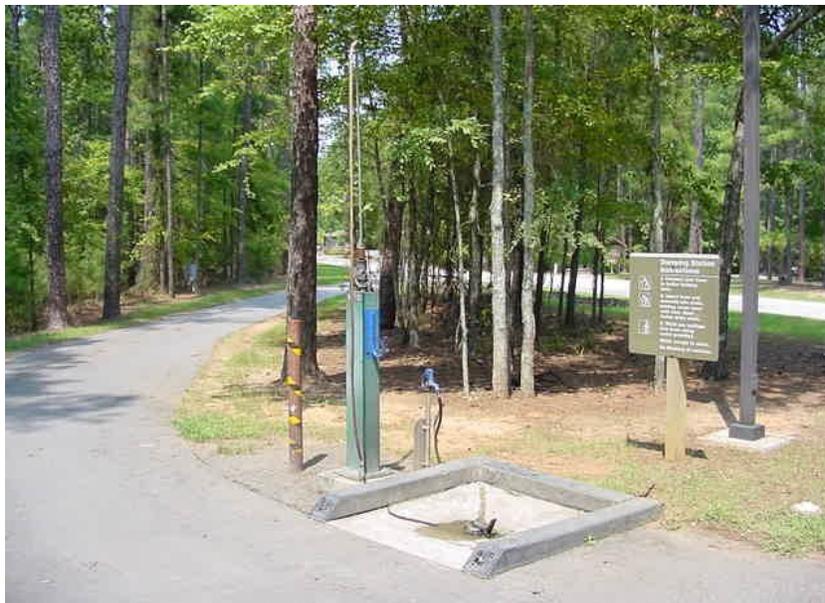
Photo L-4. Sewage dump station. Petersburg Campground, J. Strom Thurmond Lake, GA. This view shows wash down and signage. The potable water spigot is outside of photo ([Table 3.11](#))

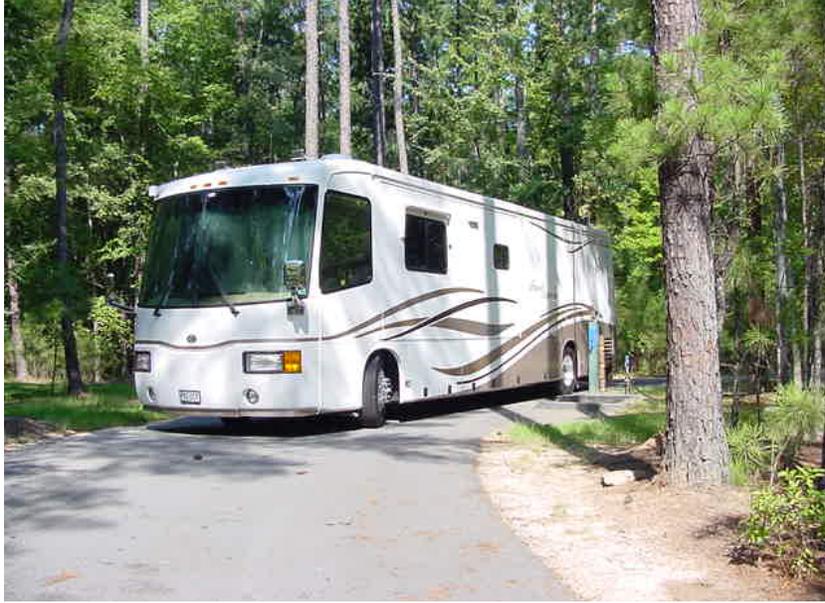
Photo L-5. RV customer using sewage dump station. Note that drain and water are on driver side of RV ([Table 3.11](#))
