CHAPTER III

Construction of X-Ray (Libby) Bridge

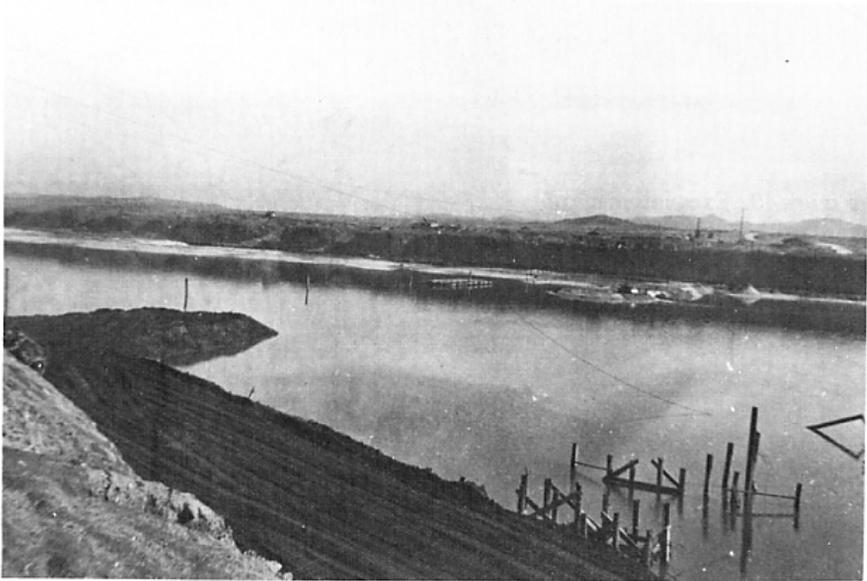
Figure 38. The Imjin River at the X-Ray site, showing early progress on the construction causeway and test piles driven in November 1952 to determine the depth of bedrock.

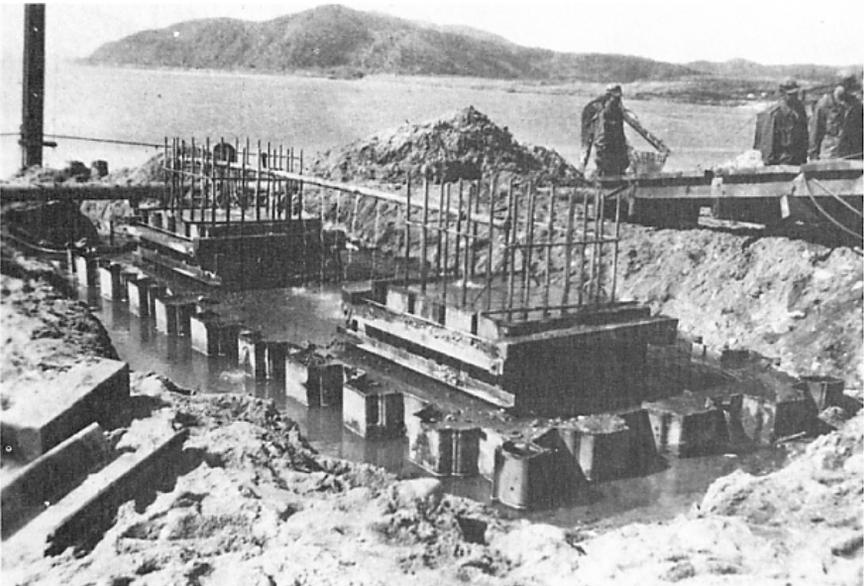
Figure 41. Cofferdam 3 filled with 240 cubic yards of concrete constituting the initial or A pour. Water is being used to cure the concrete, and the scaffold floor at right is ready to be set in place.

The pier bases were constructed by driving grooved sheet piles to form a rectangular caisson which was then excavated to bed-rock and filled with concrete. (*Figures 40 and 41*) The tolerance allowed in rolling the sheet piling in Japan was too great; in some cases it varied as much as three-quarters of an inch in width. Some of the piles were painted with red lead and some were not. The tolerance was less on the painted piles, and most of the splits in the piling were found at junctures of the two types. Also the corner piles had ball-and-socket joints, while the side piles had thumb-and-finger joints; this again made it very difficult to fit properly. The tolerance in the grooves caused leaks all up and down the joint. Lead wool was used to pack the joints, but this did not stop the water. Eventually soft wooden wedges, driven into the joints, proved to be a fairly effective means of stopping the flow.⁴

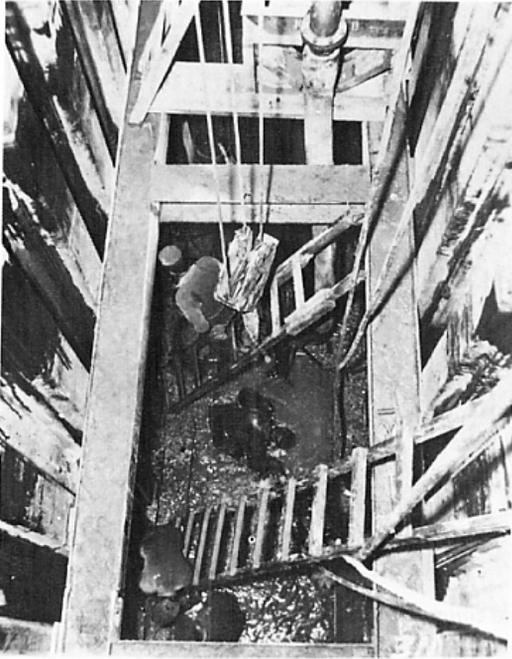
Figure 42. Interior view of a cofferdam showing 12-inch H-beams, or whalers, which enabled it to withstand outside pressure. Buckling of the H-beam is visible at the upper left.

It was found to be a general rule that the more water that was pumped out of a cofferdam, the more likely a blowout was to occur under the pile. This was due to the decreasing inside pressure.⁶ (*Figure 42*) In the later stages of the cofferdam work, divers were used to great advantage to overcome this. The cofferdam was allowed to fill with water when the bulk of the excavation had been accomplished, and divers were used to clean the bottom of all sand, gravel, and loose bedrock. Following this, an initial pour of three to four feet of concrete was made, keying the pier to bedrock and sealing off the bottom of the cofferdam. The cofferdam could then be dewatered and work continued "in the dry." Only cofferdam 8 was poured completely in the dry.

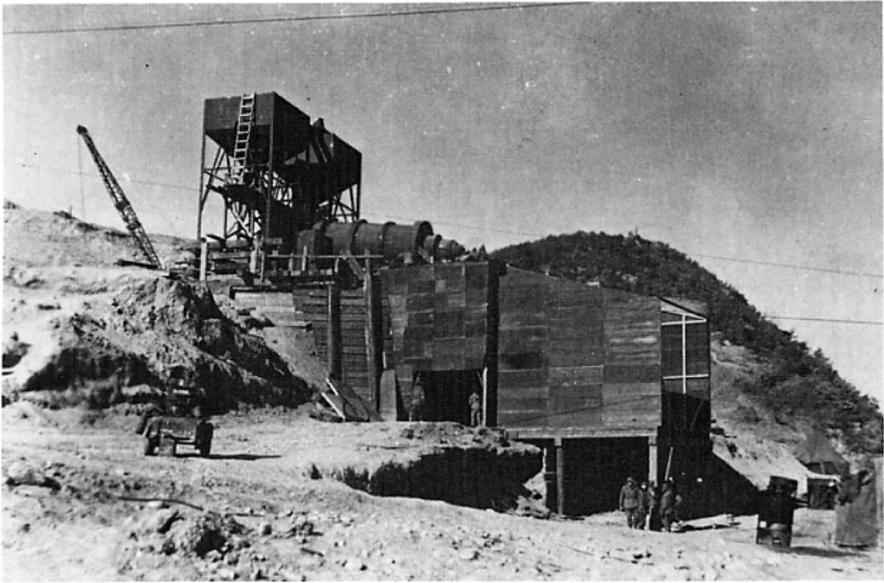
Figure 44. Close-up view of the concrete batch plant showing aggregate bins and, at bottom, locations where dump trucks and mixers were filled.

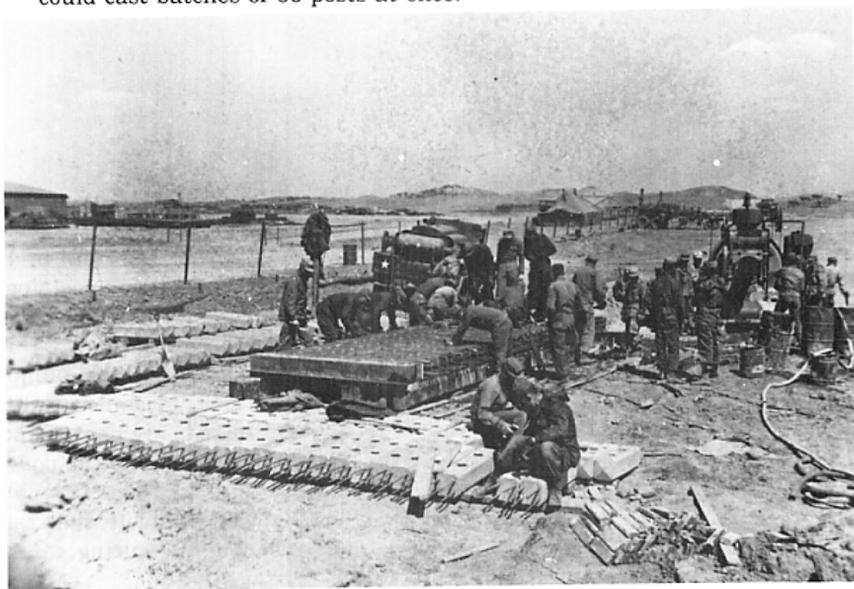
Figure 49. Soldiers casting guardrail posts. The reusable forms shown could cast batches of 66 posts at once.

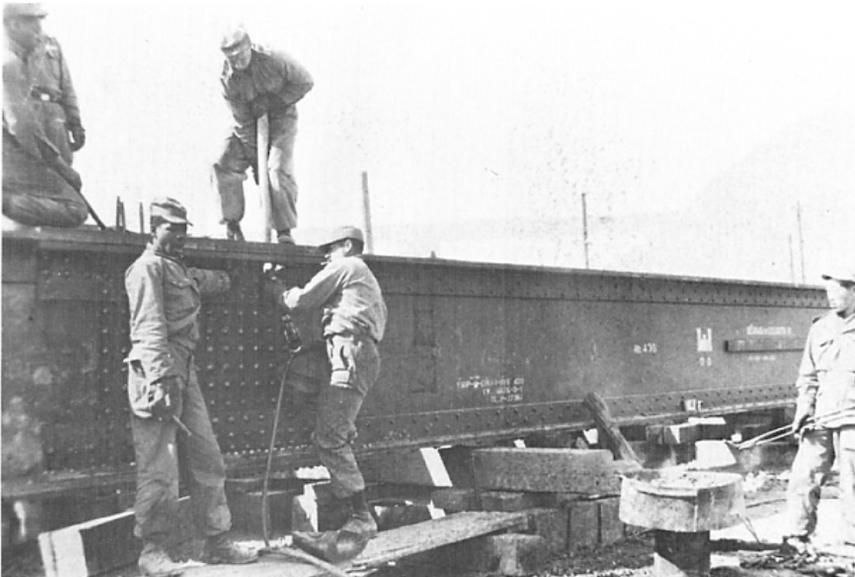
Figure 51. Riveters at work on steel beams. Newly trained American and Korean riveters developed their skills so quickly that a 121-foot span was launched with a deflection of only 17 inches.

On the day riveting began, the only man in the battalion who had civilian experience as a riveter departed for home. However, a week's schooling and the help of two Korean riveters soon turned out good crews. The rivet hammers available through Army supply channels were too light for the seven-eighths-inch rivets used, and suitable hammers had to be rented from a Korean contractor.¹⁴ (*Figures 51 and 52*)

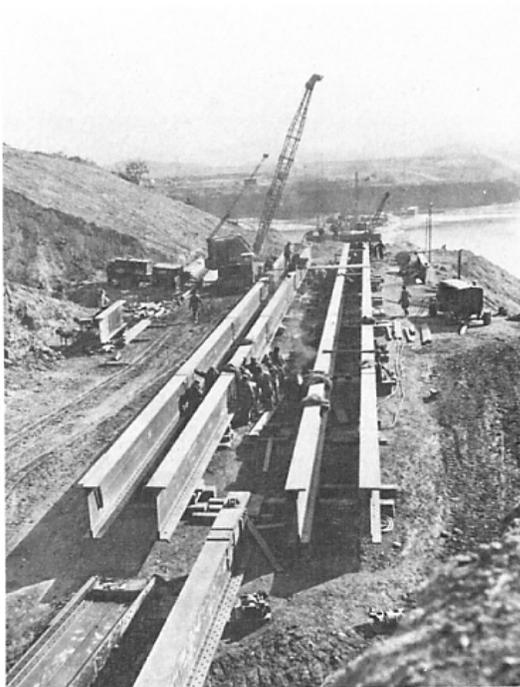
Figure 52. Steel beams being prepared for the span from the west abutment to pier 7, while riveters received training on the beam at left center.

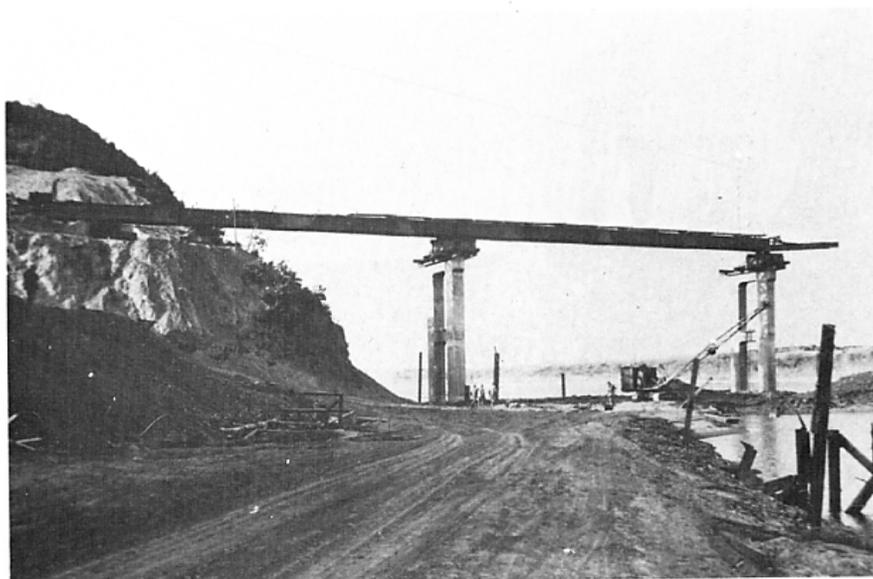
Figure 53. Steel beams in place from the west abutment across pier 8 to pier 7. The 30-foot launching nose may be seen beyond pier 7.

phragmed) with six-by-six-inch angle iron and fifteen-inch channel iron between beams to form a pair of girders as a unit for launching. This downstream pair was then launched with a 30-foot launching nose fixed to the front at an upward angle to compensate for any downward deflection of the beam when it reached the pier, and a counterweight was added to the tail of the girder to prevent tipping. (*Figure 53*)

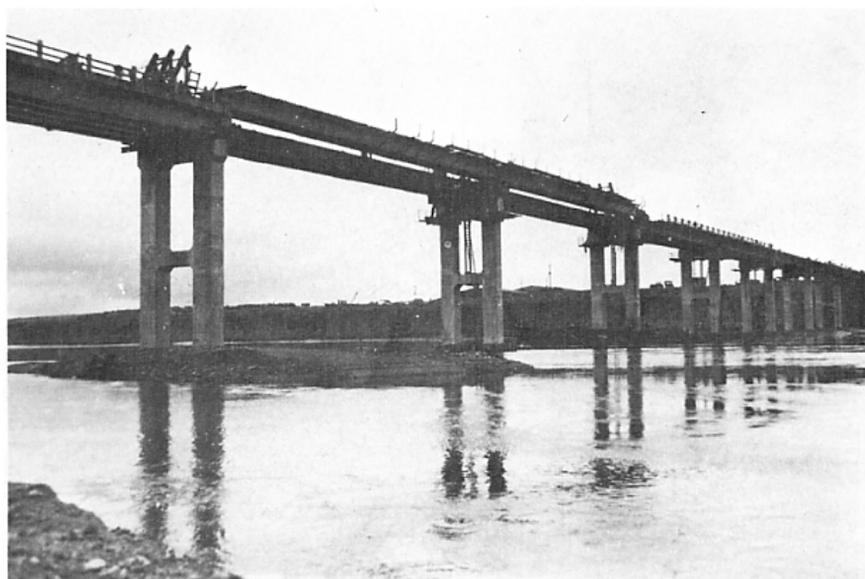
Figure 55. Chain hoist lowering girder complete with sub-decking across piers 7, 6, and 5.

Figure 56. Close-up view of chain hoist lowering downstream girder across piers 7, 6, and 5. This girder was lowered in 22 hours, a much shorter period than the eight days required to lower the corresponding girder from the west abutment to pier 7 with jacks.

The span for piers 7, 6, and 5 was fabricated on the west shore and launched over the completed decking of piers 7 and 8 and the west abutment. (*Figure 54*) Another time-saving expedient was used here in lowering the girders into position; a frame with chain hoists was anchored to the completed decking of the other spans and lowered the downstream girder in 22 hours, while with jacks

it required eight days to lower the corresponding girder of piers 7 and 8 and the west abutment. (*Figures 55 and 56*)
