Appendix M  
Photos  
Campgrounds

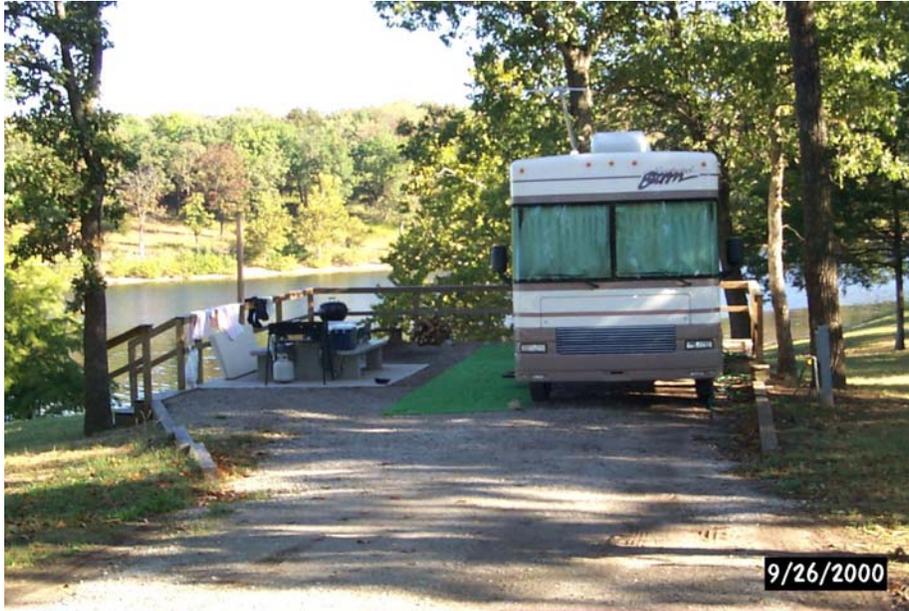
Photo M-1. Shaded and water-oriented campsite. Pomme de Terre Lake, MO. This campsite satisfies customer preferences for shade and proximity to the lake or river ([Table 5.1](#) and [Para. 5.3](#))

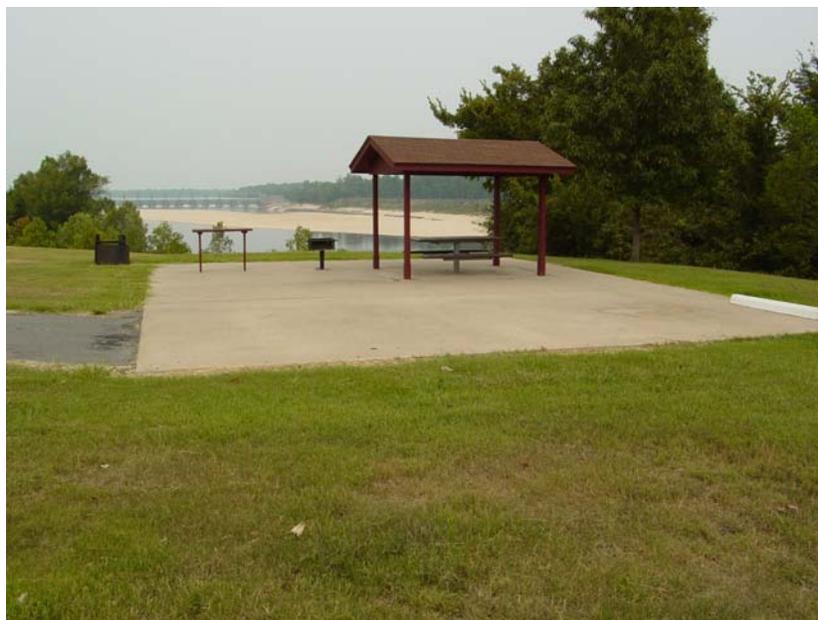
Photo M-2. Shaded UA campsite. Wilbur D. Mills Park, Pine Bluff Project, AR. This campsite is UA ([Para. 5.2.1](#)) and has a shelter to provide shade since existing vegetation is not available ([Table 5.1](#))

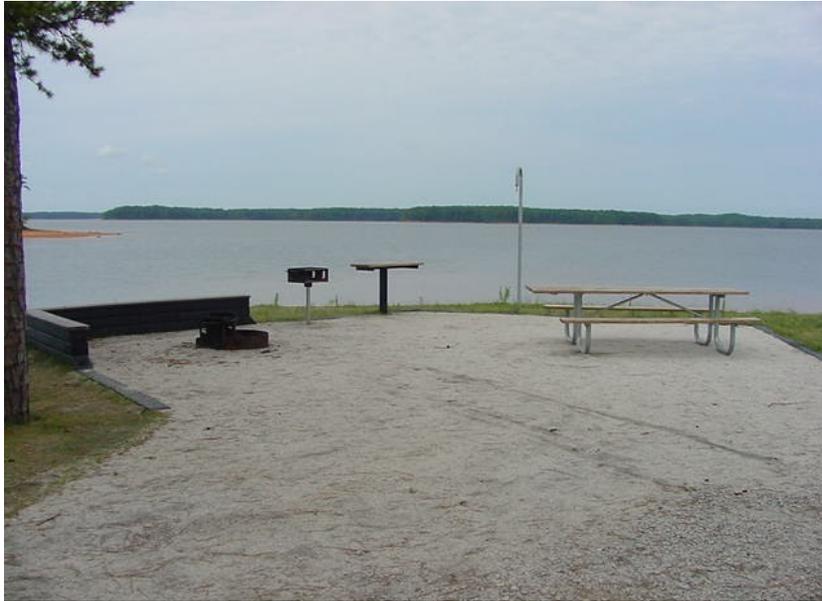
Photo M-3. Campsite amenities. Modoc Campground, J. Strom Thurmond Lake, SC. View of typical campsite amenities, to include utility table, fire ring/grill, pedestal grill, lantern hanger, and UA picnic table ([Table 5.2](#))

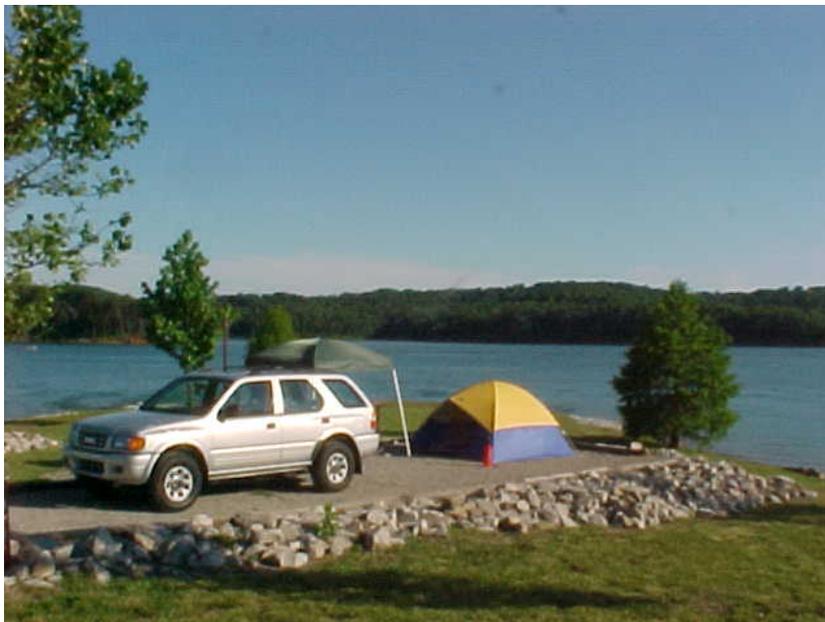
Photo M-4. Hardened living area. Moutardier Campground, Nolin River Lake, KY. Fine crushed stone surface provided ([Para. 5.3.3.1](#))

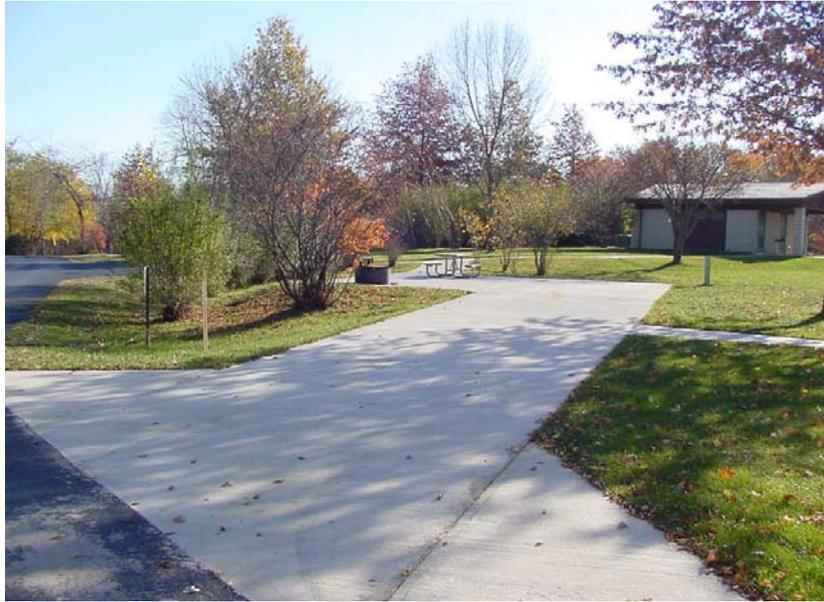
Photo M-5. Designated UA site, Example 1. Acorn Valley Campground, Saylorville Lake, IA. Fully concreted campsite (Para. 5.3.1)

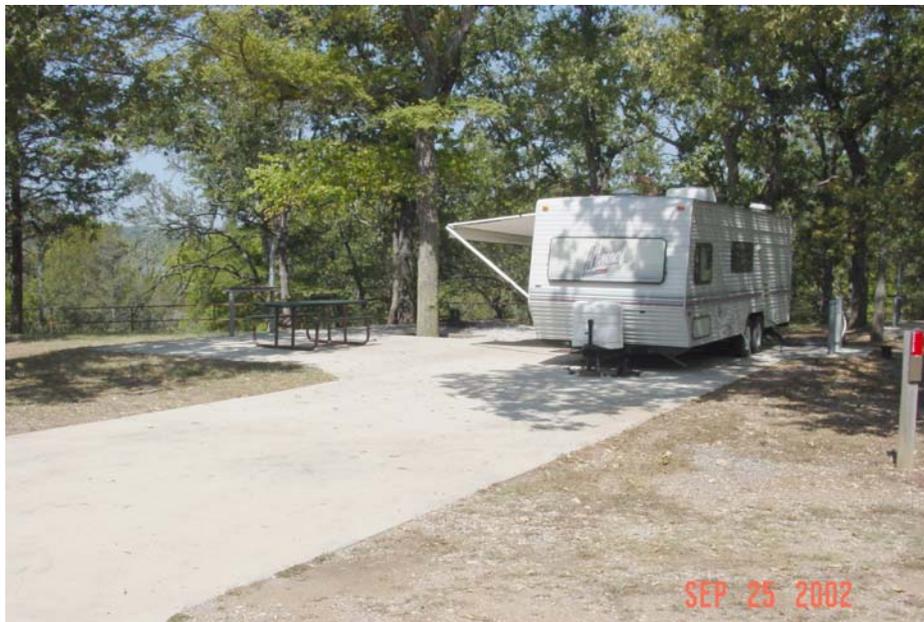
Photo M-6. Designated UA site, Example 2. Pettit Bay Recreation Area, Tenkiller Ferry Lake, OK. Fully concreted campsite (Para. 5.3.1)

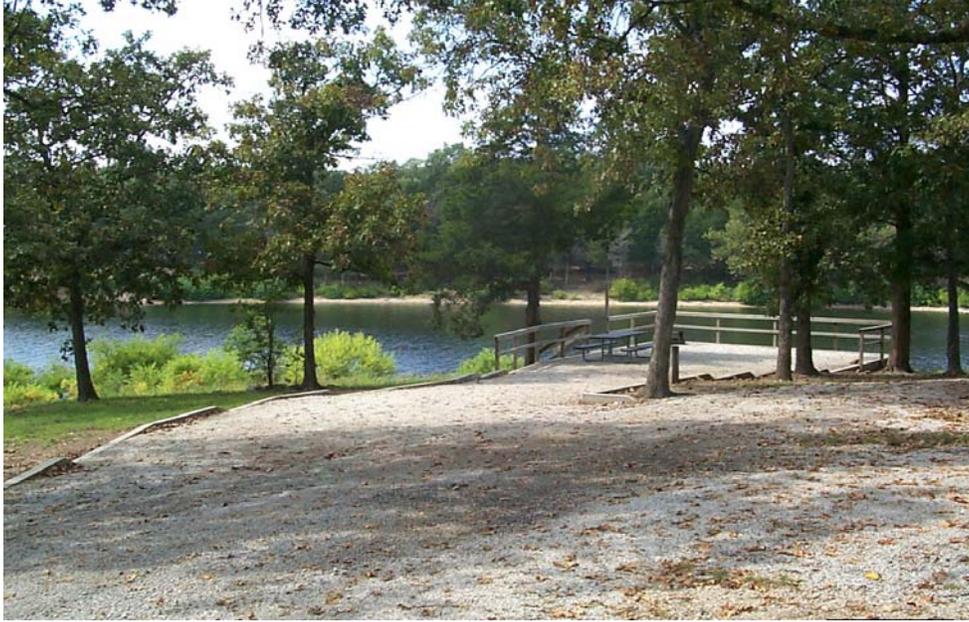
Photo M-7. Camping spur follows terrain - Example 1. Pomme de Terre Lake, MO. ([Table 5.1](#)). This photo also demonstrates hardened living area located on the passenger side, timber border, provision of room for RV slideouts, and required site amenities ([Table 5.4](#))

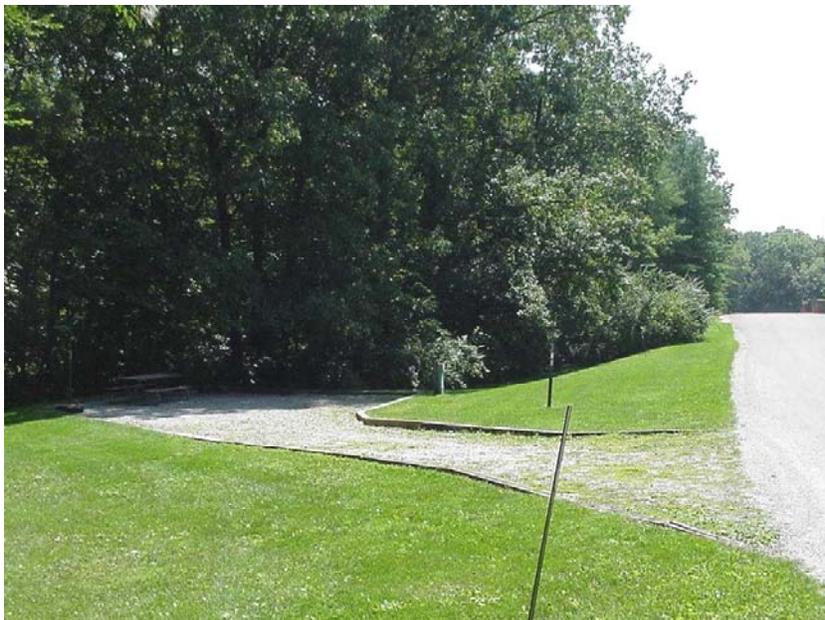
Photo M-8. Camping spur follows terrain - Example 2. Note how cut and fill are avoided by building this back-in site on the contour ([Table 5.1](#))

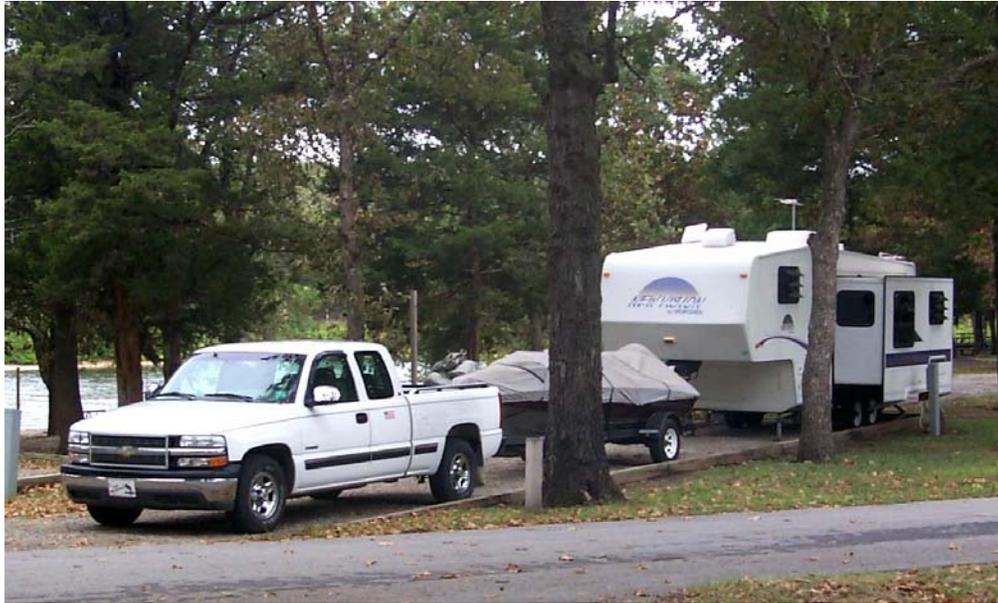
Photo M-9. Back-in site - multiple vehicles. Pomme de Terre Lake, MO. This photo demonstrates 70-ft spur length that provides additional parking space to accommodate car and boat trailer along with RV. Site provides room for RV slideouts (Tables [5.2](#) and [5.3](#))

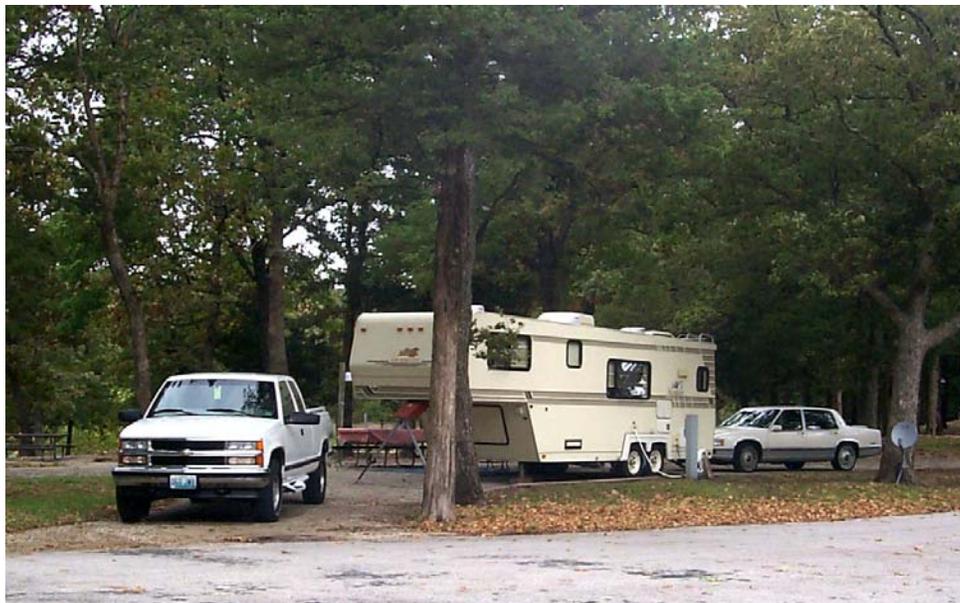
Photo M-10. Pull-through site - multiple vehicles. Pomme de Terre Lake, MO. This shaded campsite demonstrates 70-ft parking area length with room for extra vehicle, level and hardened parking area, and individual utility hookups (Tables [5.2](#) and [5.3](#))

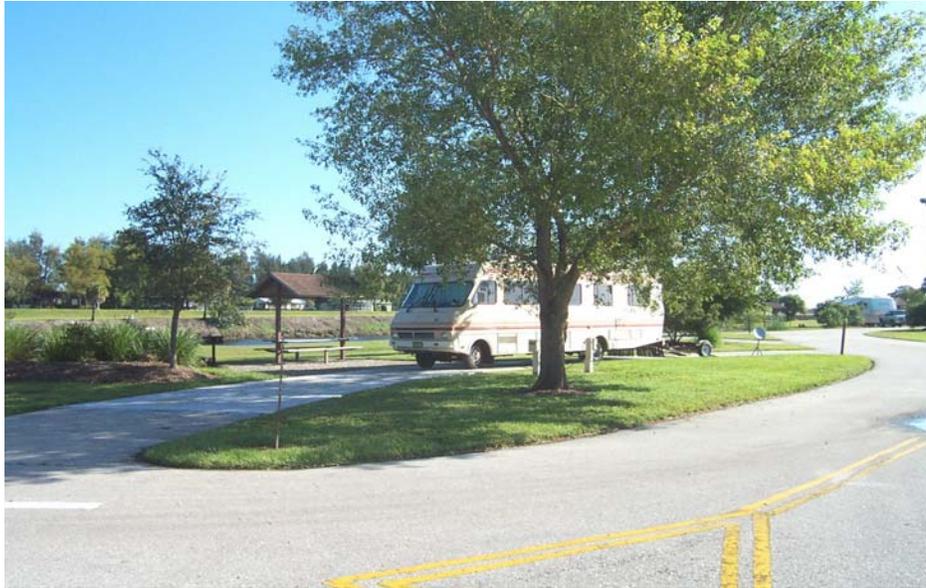
Photo M-11. Pull-through site - double. Ortona South Campground, Lake Okeechobee Waterway, FL. Note landscape plantings for buffer and aesthetics are indigeneous, low-maintenance, sustainable. Shade provided by combination of trees and shelter ([Table 5.1](#))

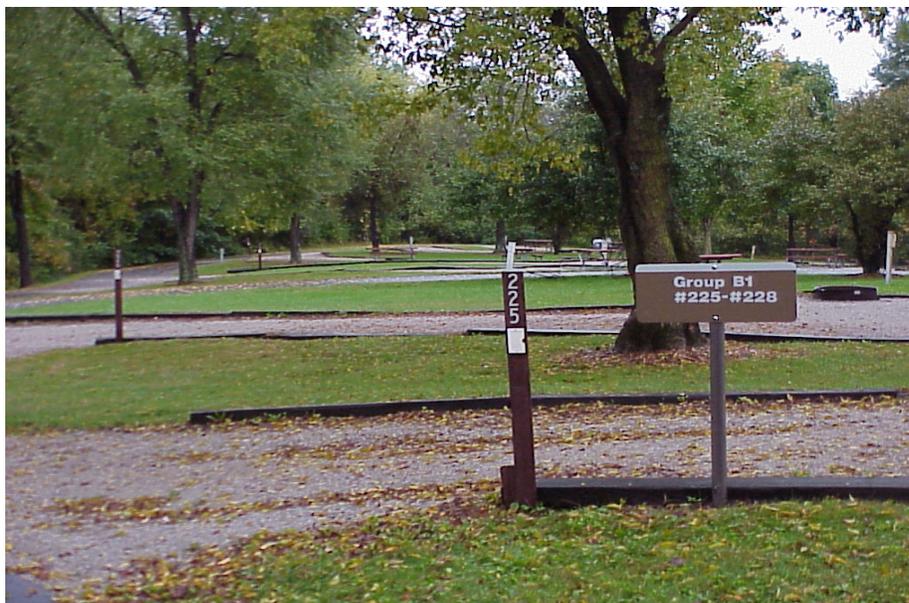
Photo M-12. Group camping area. Sugar Bottom Group Camping Area, Coralville Lake, IA. Where feasible, group campsites may be provided within a campground or in close proximity to an existing campground ([Para. 5.3.1.1](#))

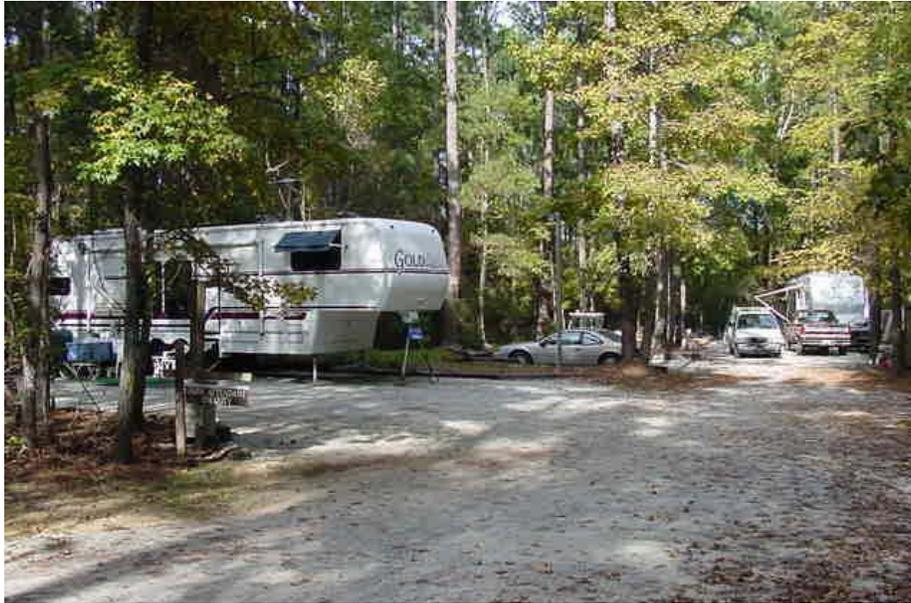
Photo M-13. Park attendant campsite. Petersburg Campground, J. Strom Thurmond Lake, GA. Located near the campground entrance, inside the gates. Vegetation screens living area for privacy. Sign helps campers easily locate attendants in the event of an emergency (Para. 5.3.1.2, Table 5.2)

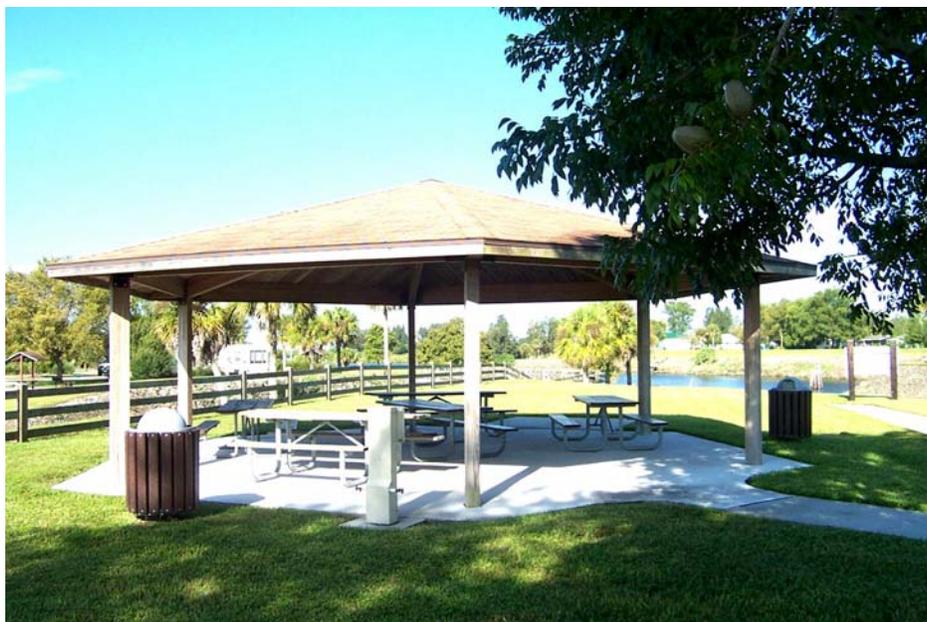
Photo M-14. Group shelter in campground. Ortona South Campground, Lake Okeechobee Waterway, FL. This communal gathering point for campers was constructed after a local Customer Care Survey indicated local demand (Table 5.2, Para. 6.3)

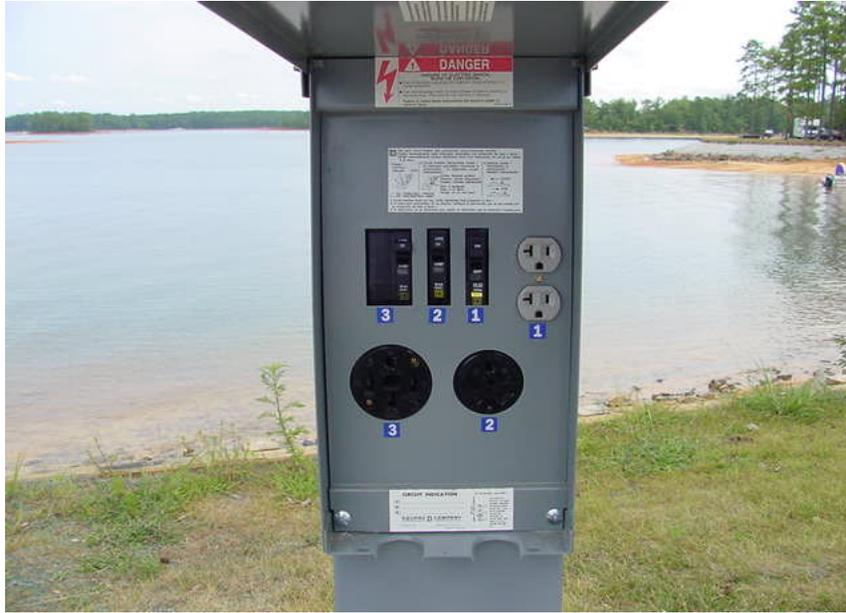
Photo M-15. Electrical Pedestal. Pedestal with 50-, 30-, and 20-amp (GFCI) hookups ([Table 5.5](#))

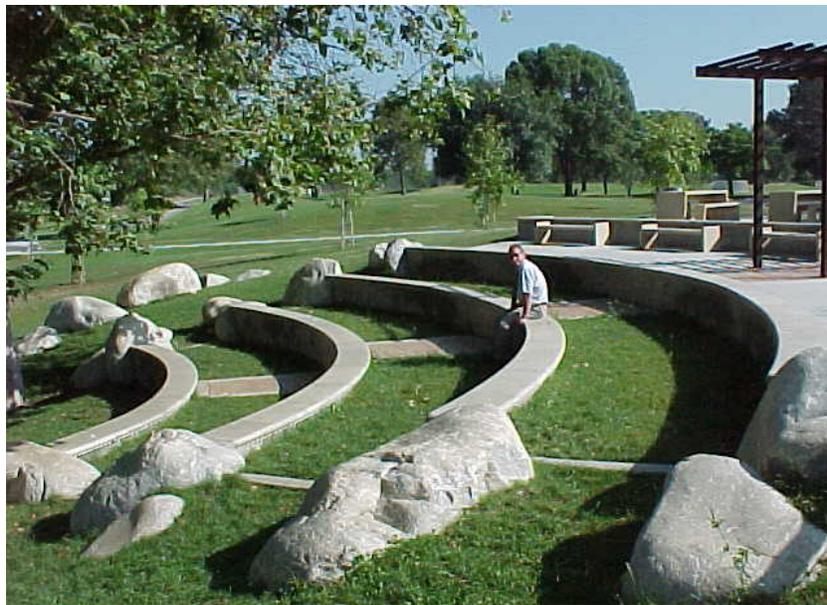
Photo M-16. Low-maintenance amphitheater. City of Los Angeles outgrant, Lake Balboa, Los Angeles District. Amphitheater is constructed of low-maintenance materials that are indigenous to the site. This is an example of a sustainable design. Note that top section is UA ([Para. 5.4.8.1](#))
